Analysis of a Practical Study for Under-Ground Cable Faults Causes

Essam M. Shaalan

Sayed A. Ward

Ahmed Youssef

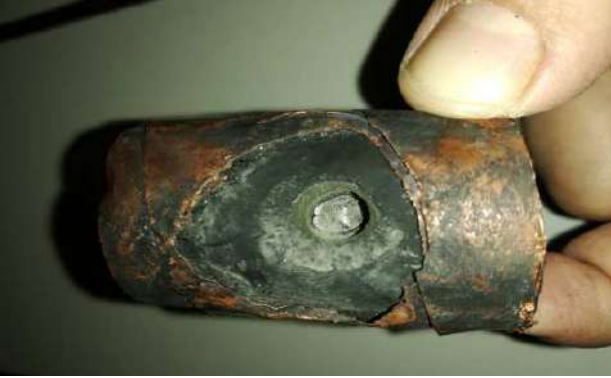
- Insulation defects during cable manufacturing: The defects may be due to existence of air voids or impurities inside the insulating material, unsymmetrical insulation layer thickness or unsymmetrical semi-conducting material layer thickness. This resulting in a non-uniform electric field distribution inside or at the insulation surface, creating high stressed points leading to partial discharge (PD) activity, creating channels of carbonization with branch-like structure resembling a tree. Once an electrical tree grows big enough and bridges the electrodes of the cable system, the cable insulation will break [4] as shown in (Fig.1).
- Conductor defects during cable manufacturing: The cable conductor may have a bad welding during its manufacturing process which leading to a bad contact resulting arcing and raising the temperature at the

Fig.1: The cable insulation breakdown by the treeing process due to existence of air voids or impurities inside the insulating material.

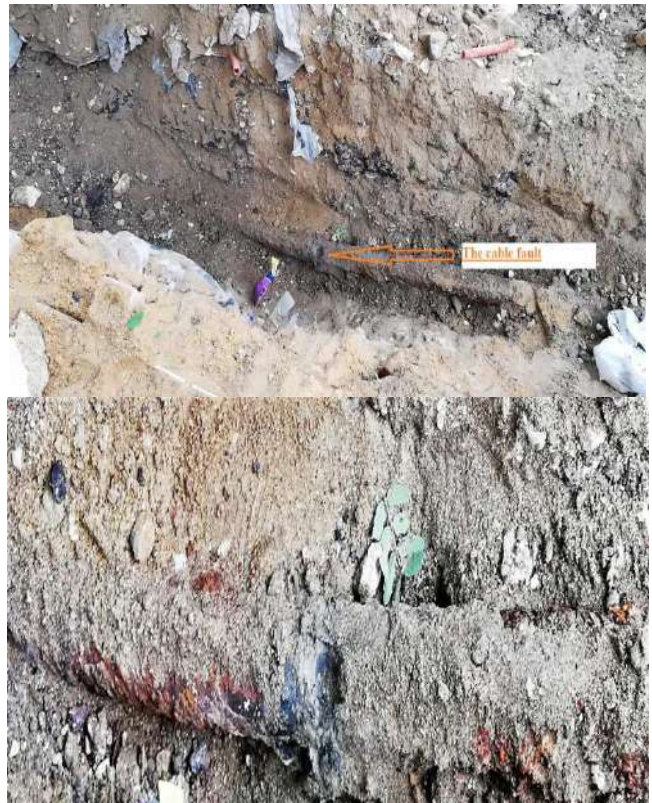
- Insulation deterioration due to cable aging: The underground cable's lifetime is estimated to be from 40 to 70 years [10] and as most of oil impregnated paper insulated cables in DOKKY medium voltage underground cable distribution networks in the Egyptian ministry of electricity are installed since more than 40 years, they are suffering from natural aging phenomena which take the form of cracks in the outer lead sheath of the cable leading to facilitate the penetration of soil contents and moisture to the internal components of the cable, creating water, trees causing insulation deterioration which will lead to breakdown [11]. The cable aging will also cause the cable's outer mechanical protection erosion so the cable will easily be damaged by any digging process beside it leads to insulation failure as shown in (Fig.2).

Fig.2: Oil impregnated paper cable insulation breakdown due to aging and existence of old digging process beside it.

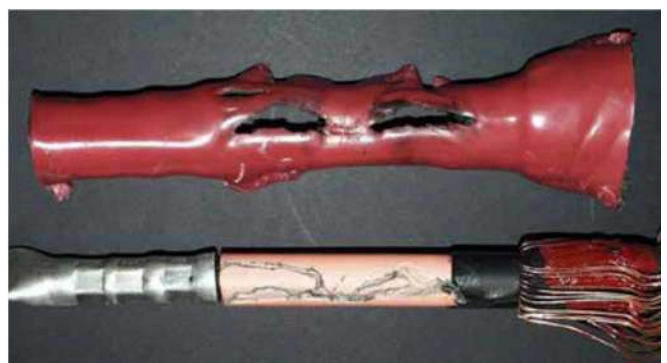
On the other hand, in case of termination fault the partial discharge may be occurred on the outer surface of the solid insulation and is called surface discharges causing the well-known surface tracking [13]. The surface tracking is a result of the partial discharge activities at the irregular sharp needle-like point edges which having very strong electric field values sufficient to ionize the surrounding air and converting it to a conductive, moreover the existence of contamination and moisture may lead to a leakage path to ground and over the time, a partially conducting carbonized electrical trees will be formed which causes a greater stress on the remaining insulation, which leading to further growth of the damaged region and resistive heating along the tree [14, 15]. Finally, it will cause a complete insulation breakdown with electrical explosion. (Fig.3) shows cable termination insulation failure due to electrical surface tracking

Fig.3: Cable termination insulation failure due to electrical surface tracking [16].

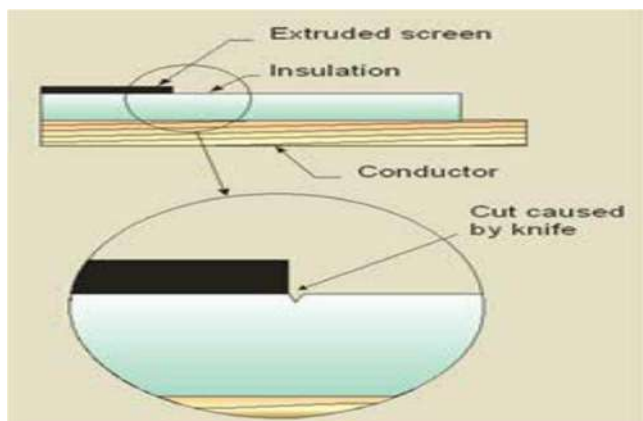
- Using unsuitable tools for cable preparing will result in unsymmetrical and non-smooth cable insulation surface with sharp edges, causing high stressed points inside the joint or the termination and leading to the appearance of the partial discharge activities causing total breakdown after a short time. (Fig.4) shows Knife cut into the insulation surface caused using an unguarded knife to remove the outer semiconductor layer.

Fig.4: Knife cut into the insulation surface caused by use of an unguarded knife [16].

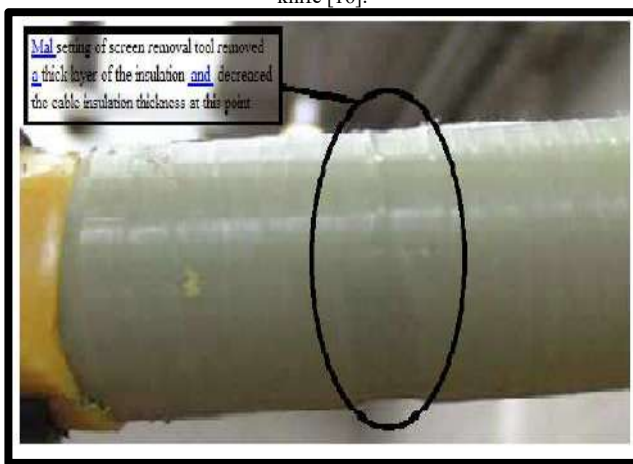
- Mal setting and/or misuse of screen removal tool will result in removing a thick layer of the insulation during the removal of the semiconductor layer, decreasing the cable insulation at this point and creating rough insulation surface as shown in (Fig.5). Moreover, if the removal of semi conductive layer is not done accurately, a screen edge having projections or filaments will be created as shown in (Fig.6). In addition, if the removal of conductive screen material is not completed and part of it is still found as shown in (Fig.7), it will lead to the occurrence of partial discharges inside the joint, which causing joint failure. (Fig.8) shows the immediate failure due to not removing insulation screen totally during installation.

Fig.5: Extremely rough insulation surface resulting from incorrect setting and/or misuse of screen removal tool [16].

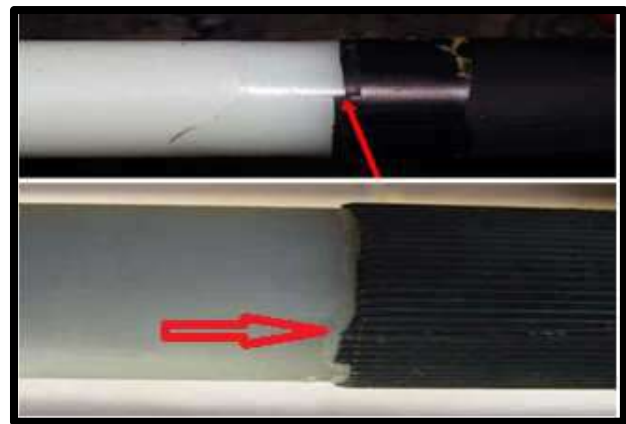
Fig.6: Screen edge having projections or filaments [16].

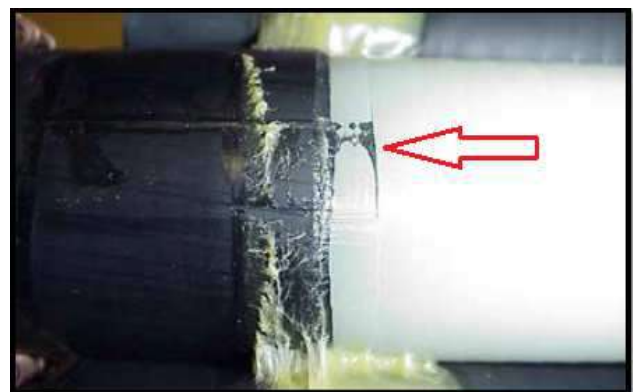
Fig.7: Incomplete removal of conductive screen material from insulation surface [16].

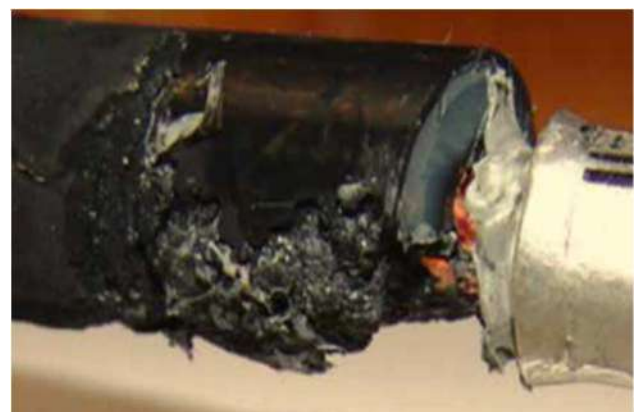
Fig.8: Immediate failure due to insulation screen not being removed during installation [16].

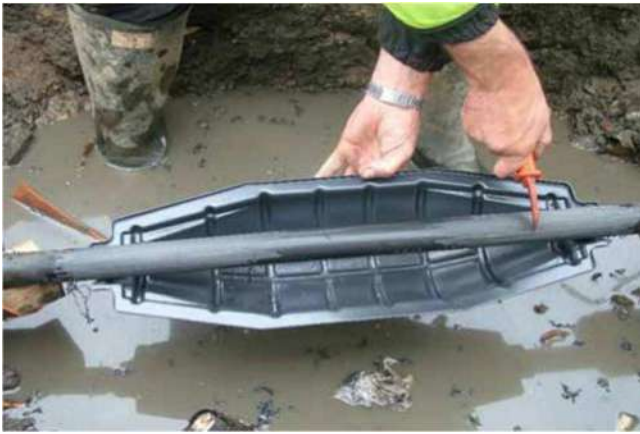
- Bad crimping of the joint splice connector or termination lugs leading to the bad conductivity of this part, which cause resistive heating of this region causing insulation failure.
- Cutting of the stress control tube leads to unsymmetrical electric field distribution inside the joint.
- Non-use of the mastic tape sealing for water protection, this will permit the water leakage into the joint.
- Bad restoring of metallic screen by welding, this leads to a bad screen shielding to electric field.
- Non-use of the joint armour in armoured cables as a result the joint insulation may suffer from mechanical deformation due to high mechanical stress.
- Joint installation on unsuitable location (garage entrance – trough the road – beside water source -....) as shown in (Fig.9).

Fig.9: The joint installation beside permanent water source [16].

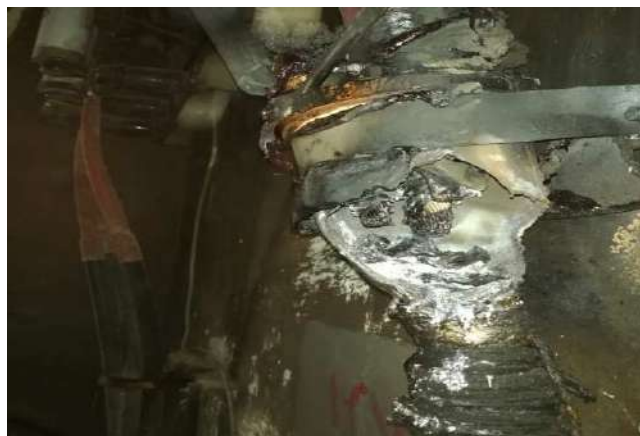
- Non-use of the sheds in case of outdoor termination, this leads to surface partial discharge in case of moisture or fog conditions.
- Sometimes the panel may have moisture, which condensate on the outer surface of the termination causing surface tracking leading to insulation failure with time, in case of oil impregnated paper cable the termination is filled with oil which may absorb the moisture from the surrounding medium inside the panel causing a repeated partial discharge within the oil, as a result the oil's chemical properties will be changed and a conducting carbonized electrical tree will be formed resulting in a total breakdown with great explosion after a period of time. The explosion may also occur due to oil dryness from the cable termination. (Fig.10) shows the expulsion of oil impregnated paper, oil filled termination.

Fig.10: The expulsion of oil impregnated paper oil filled termination.

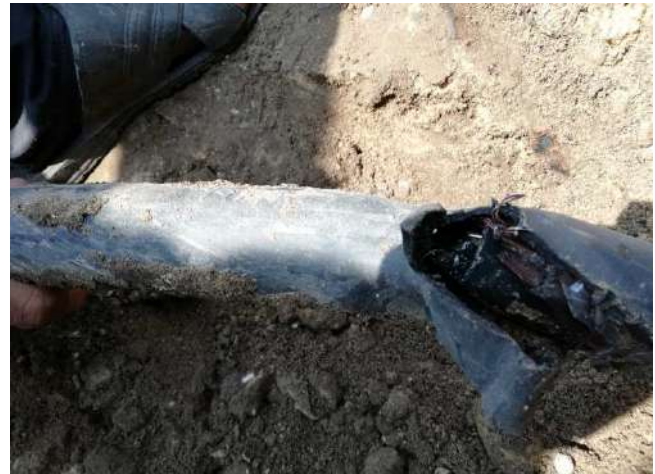
The cable may be suddenly exposed to high mechanical stress by mechanical instrument which causes insulation failure. (Fig.11) shows the cable insulation failure by mechanical compressor digging instrument.

Fig.11: The cable mechanical fault by mechanical digging instrument.

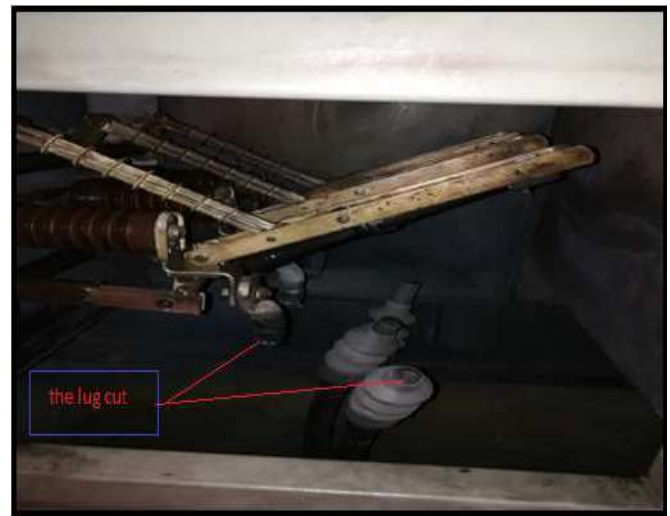
Cable lugs may totally disconnect or cut off due to short circuit between two or three phases or phase to ground, due to passage of snake on these lugs or due to using inefficient lugs to the cable conductor size, type or not correctly crimped, resulting in an open circuit fault. (Fig.12) shows the destruction of the cable termination lugs.

Fig12: The destruction of the termination lugs.

Sometimes due to bad workshop the edge of the insulation end point is left sharp, if the termination lug is not installed according to the dimensions (i.e. the length of the bare cable conductor $>$ the lug length) there will be a small air filled the gap between the lug end and the insulation end point,

The electric field will be very high in this region causing P.D with arcing specially with moisture existence, increasing the temperature in this region and cause punching of the conductor in this region, finally leading to the lugs to be destroyed by explosion.
