MICROSTRUCTURE STUDY OF DETERIORATED ISLAMIC MONUMENTS IN CAIRO

Mohamed O. Ramadan¹

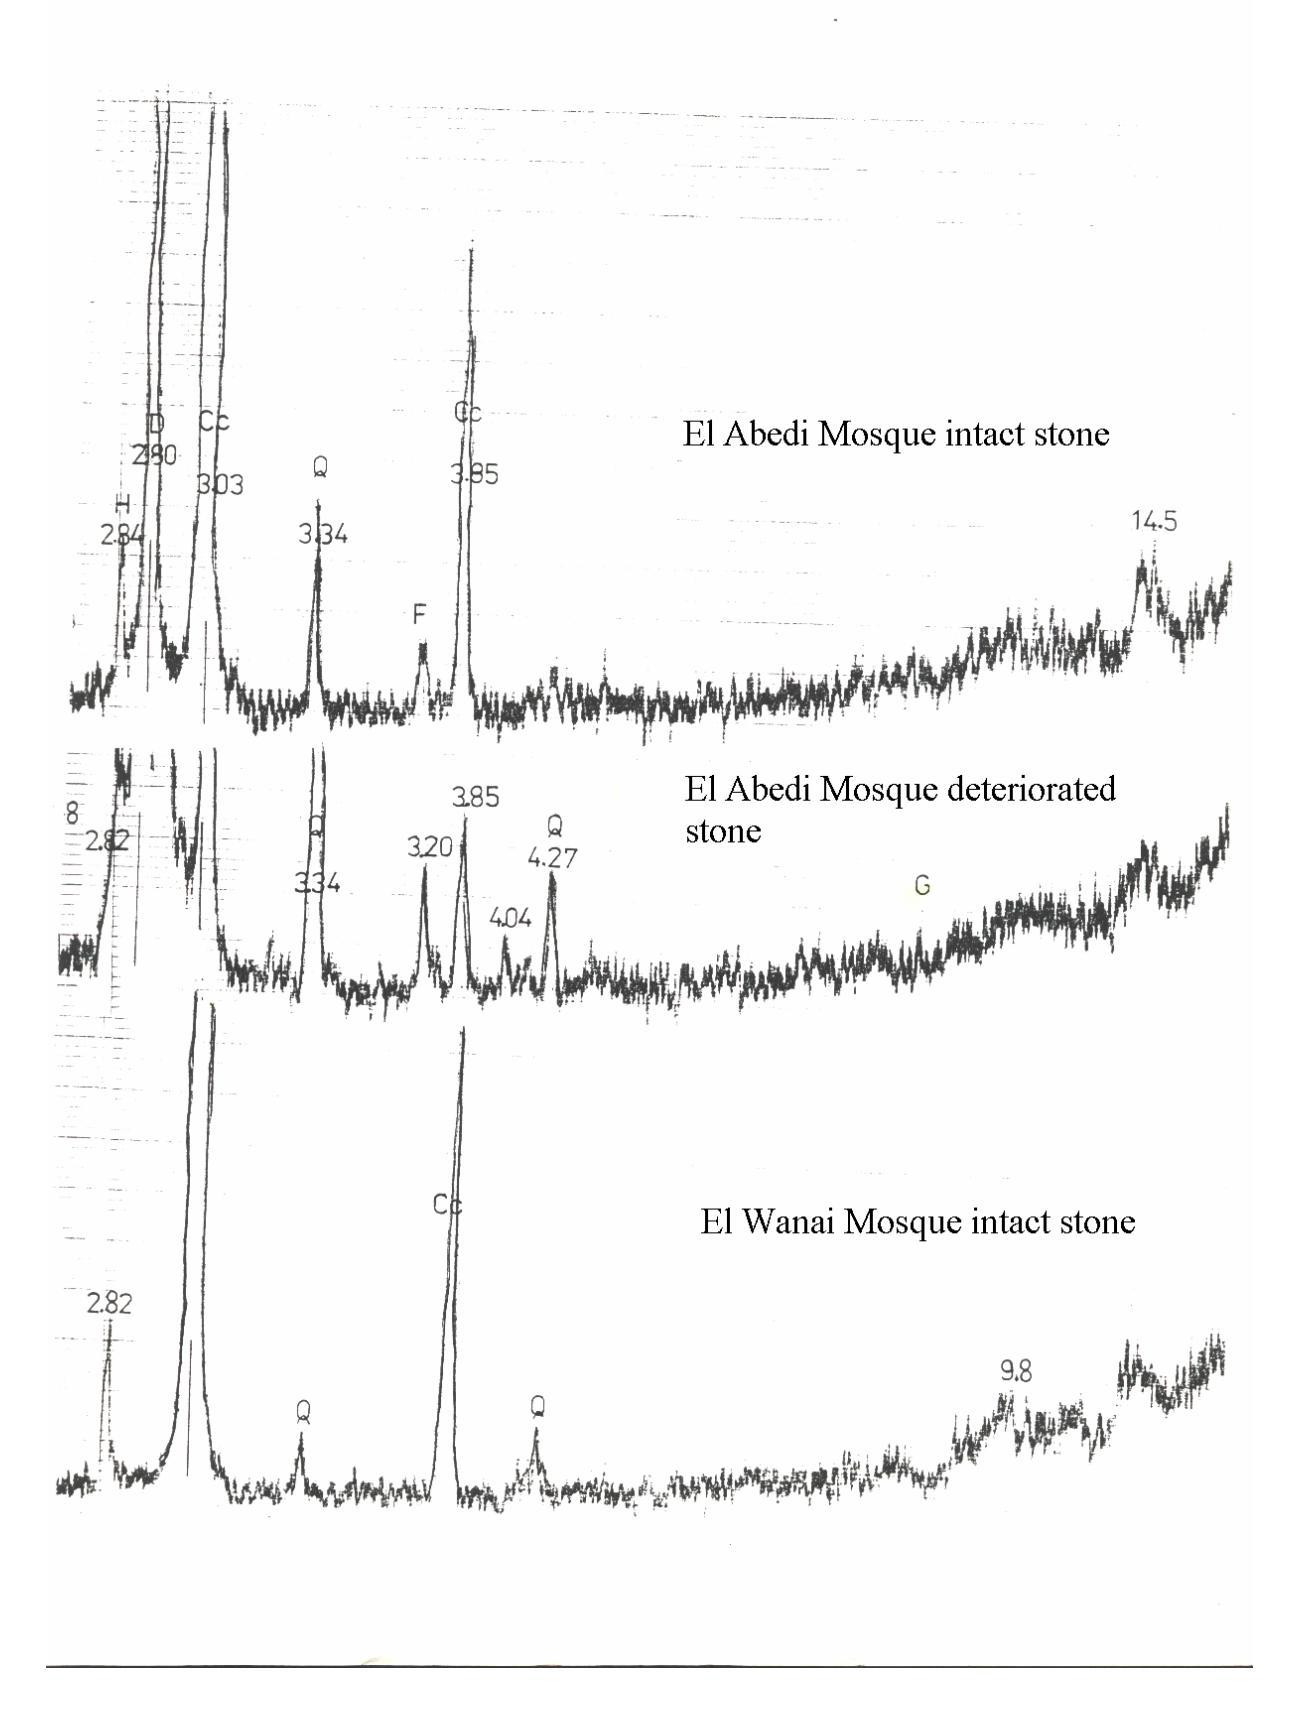
XRD was used to study the chemical composition of the intact and deteriorated stones of the investigated monuments. Figures 1 shows a sample of XRD results on El Abdi and El Wanai mosques. The XRD diagram shows that the stones are typically composed of Calcite (Cc), Quartz (Q), and varying amounts of Dolomite (D). The deteriorated stones of the tested monuments have almost the same phase content of the intact stone, indicating that, the deterioration process did not alter the chemical composition of the stones.

Figure 1: XRD analysis of intact and deteriorated stones from El Abdi and Wanai mosques.

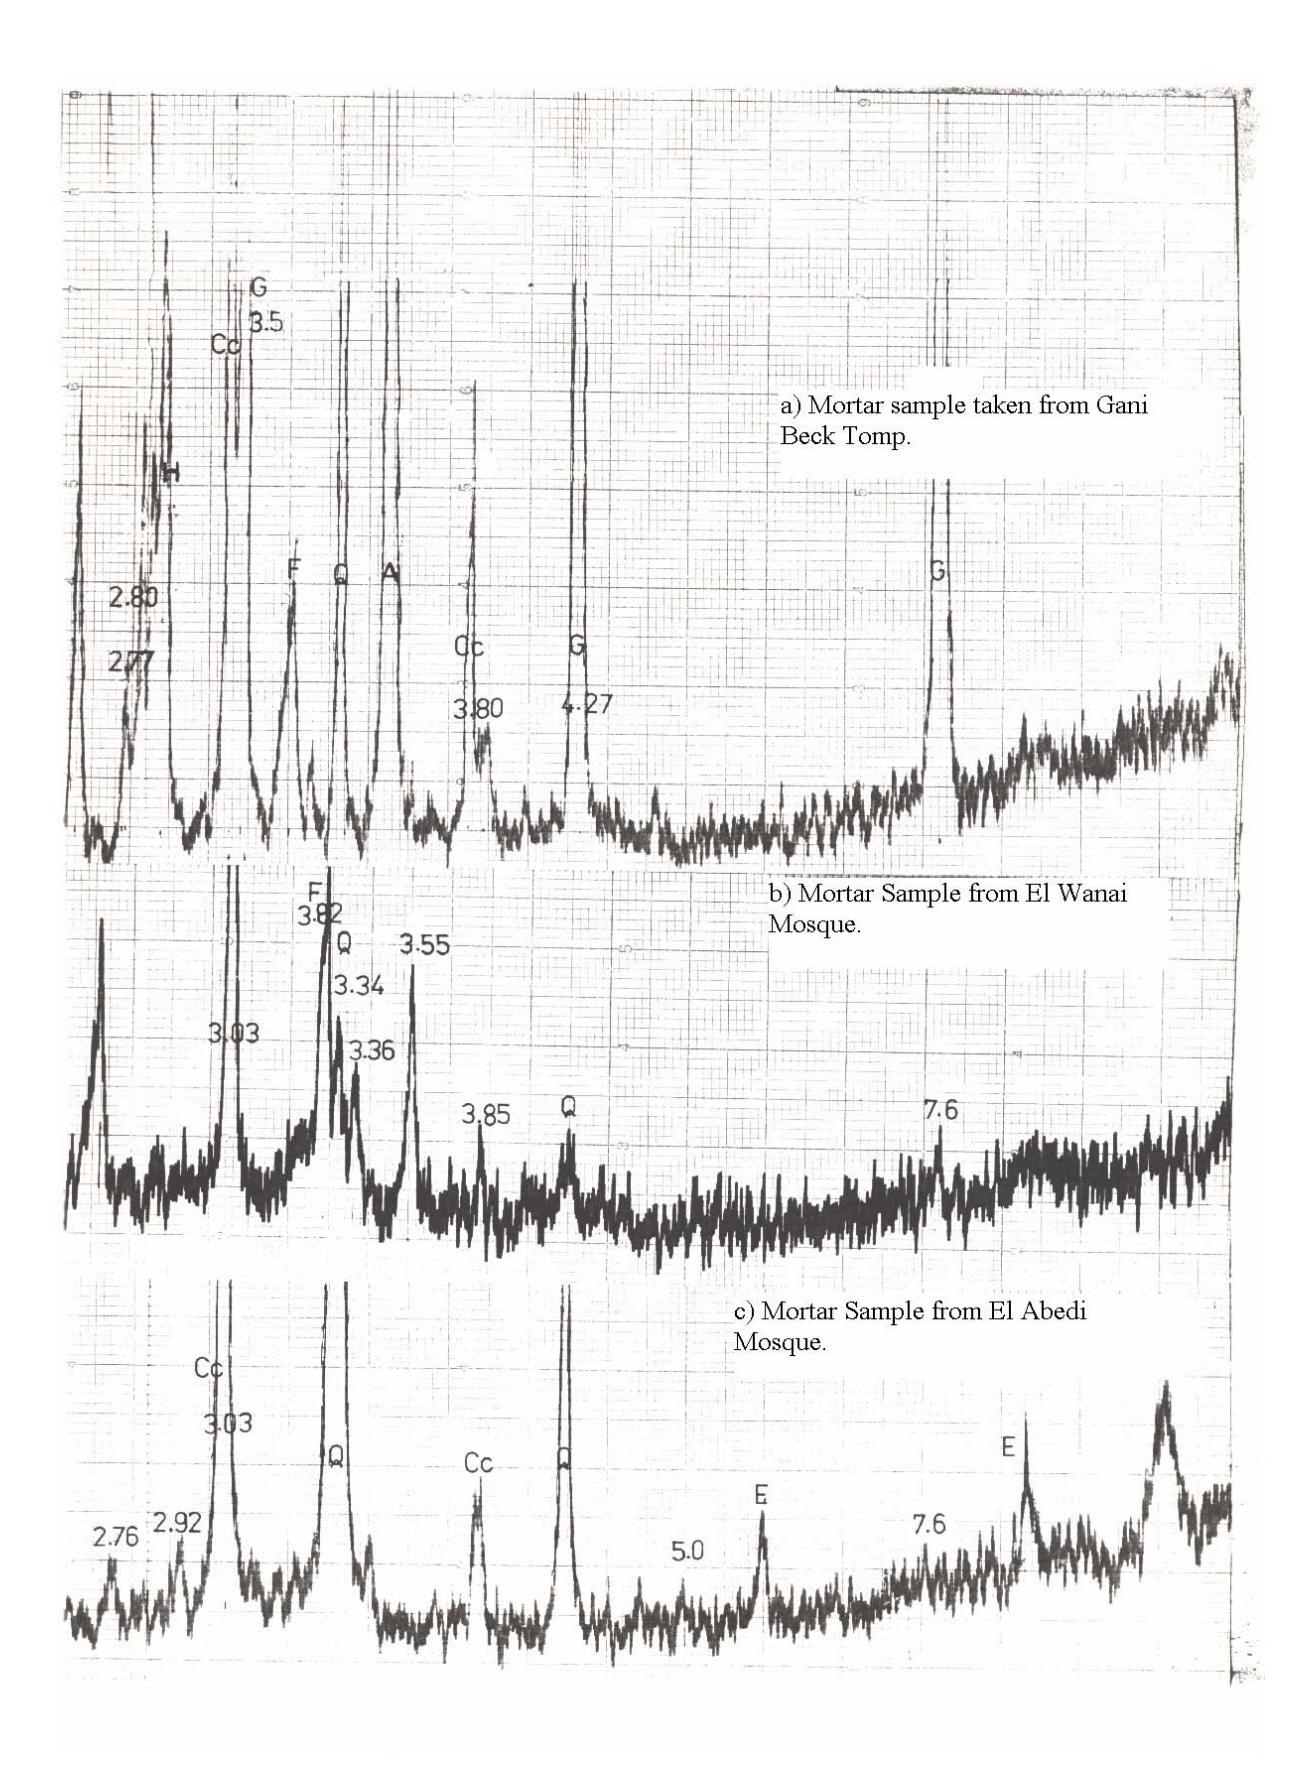
Figure 2, demonstrates the results of XRD tests on mortars taken from Gani Beck tomb (a), El Wanai mosque (b) and El Abedi mosques (c). Mortars from Gani Beck tomb and El Wanai mosque appeared to be standard ancient mortars as they contained Gypsum (G), Lime, demonstrated as Calcite, (Cc) and quartz (Q). In contrast, El Abedi mosque mortar showed the presence of Ettringite (E) which is an indication of using the contemporary Ordinary Portland Cement (OPC) in mortars. It should be noted that, OPC-mortar use in restoration of ancient monuments is firmly forbidden due to its adverse effects on this type of buildings [3,4,5].

Figure 2: X-Ray Diffraction on mortar samples taken from different locations in the tested monuments.

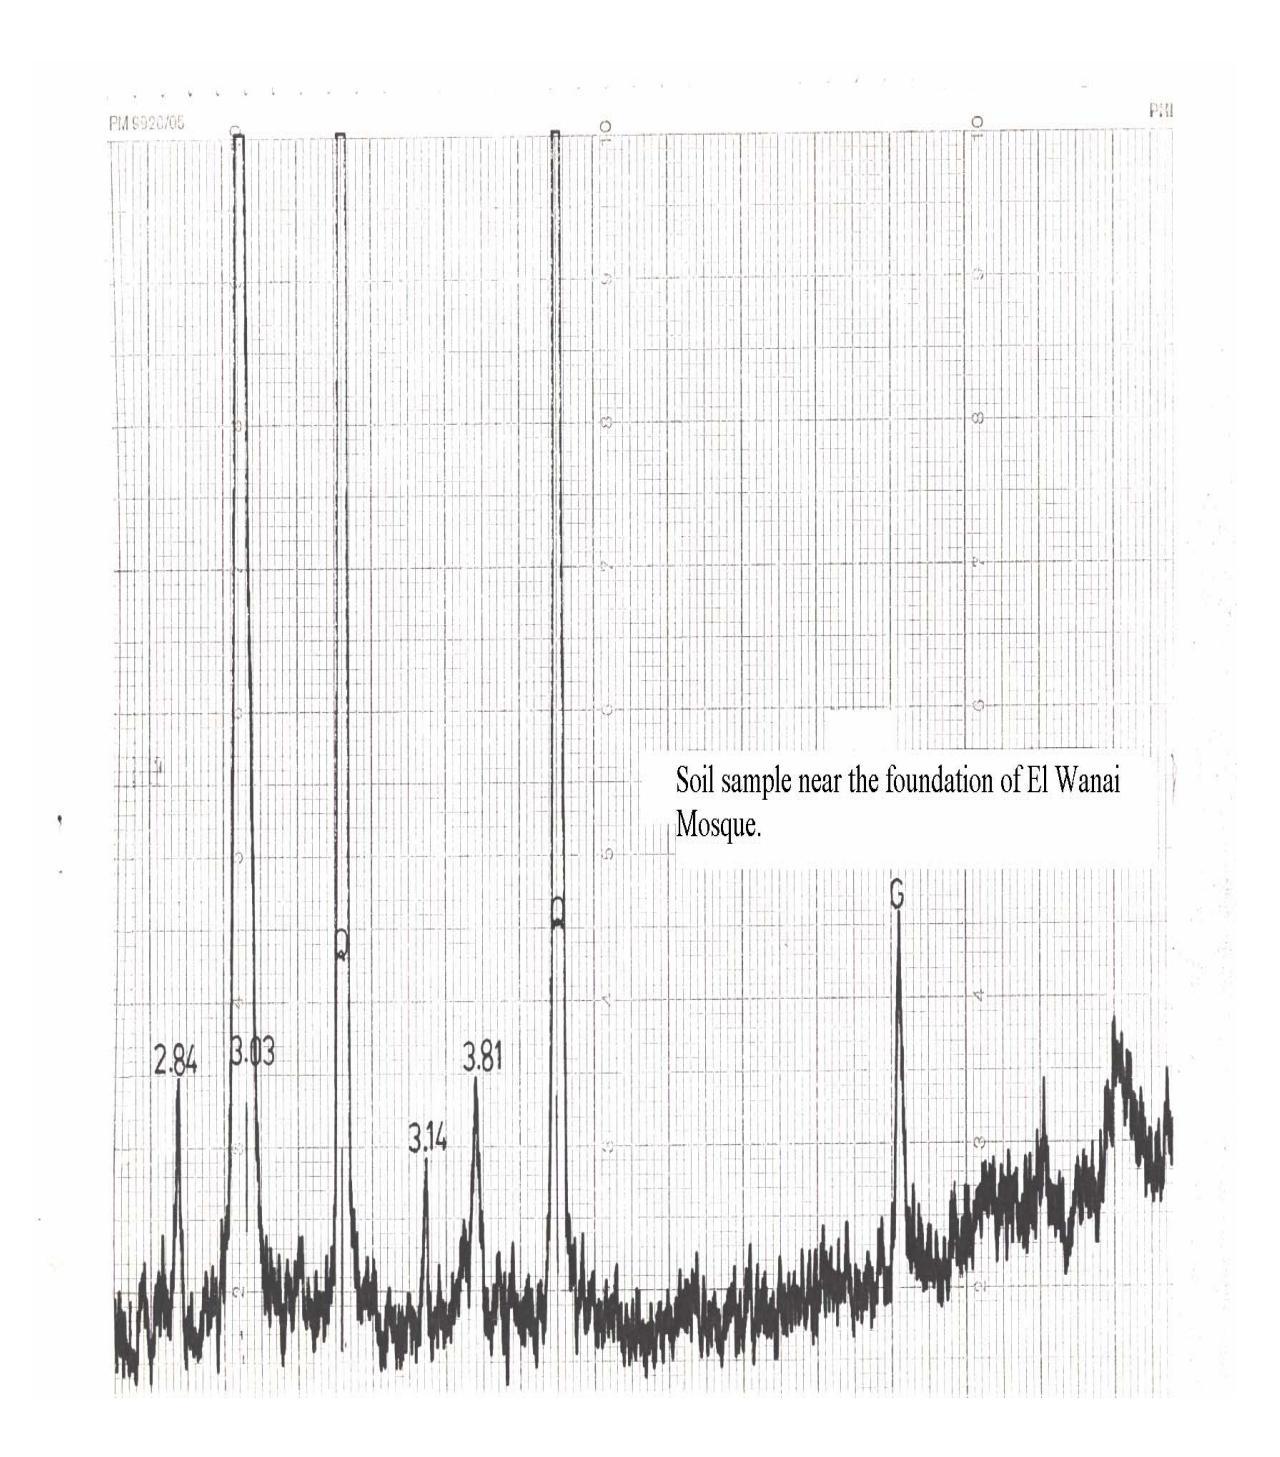
Figure 3, views the XRD test results on soil sample near the foundation of El Wanai mosque. The soil samples have Gypsum (G) content of about 4%, Calcite (Cc) of 14.8% and very strong Quartz (Q).

Figure 3: XRD test result on soil sample near the foundation of El Wanai Mosque.

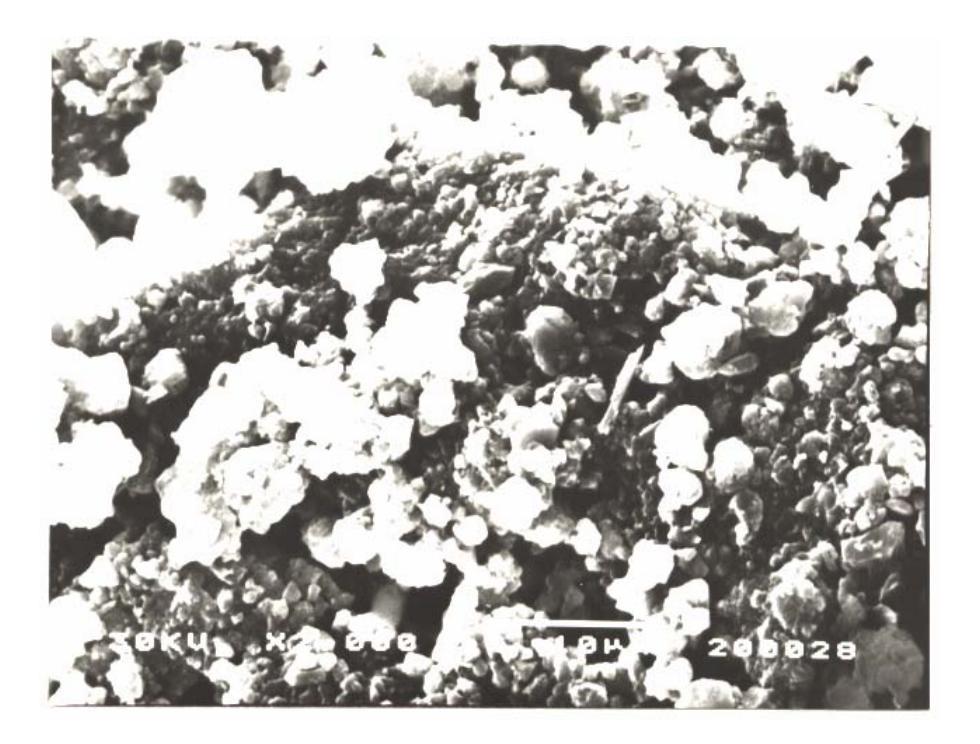
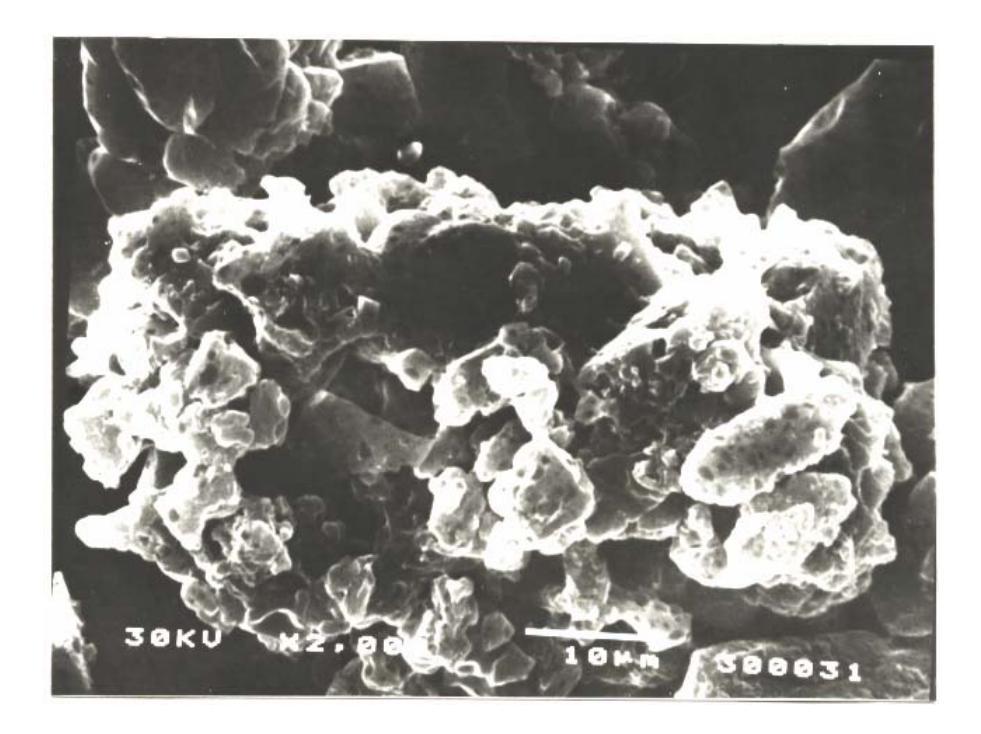
Several SEM photographs were taken for both intact and deteriorated stones. Figures 4 and 5 demonstrate the state of the body of the stones with 2000 time magnification. It can be seen from figures 4 and 5 that the intact stone body appears to be more dense compared to that of the deteriorated stone.

Figure 4: SEM photograph of intact stone from El Abedi mosque.

Figure 5: 2000 time magnification of deteriorated stone from El Abedi mosque.

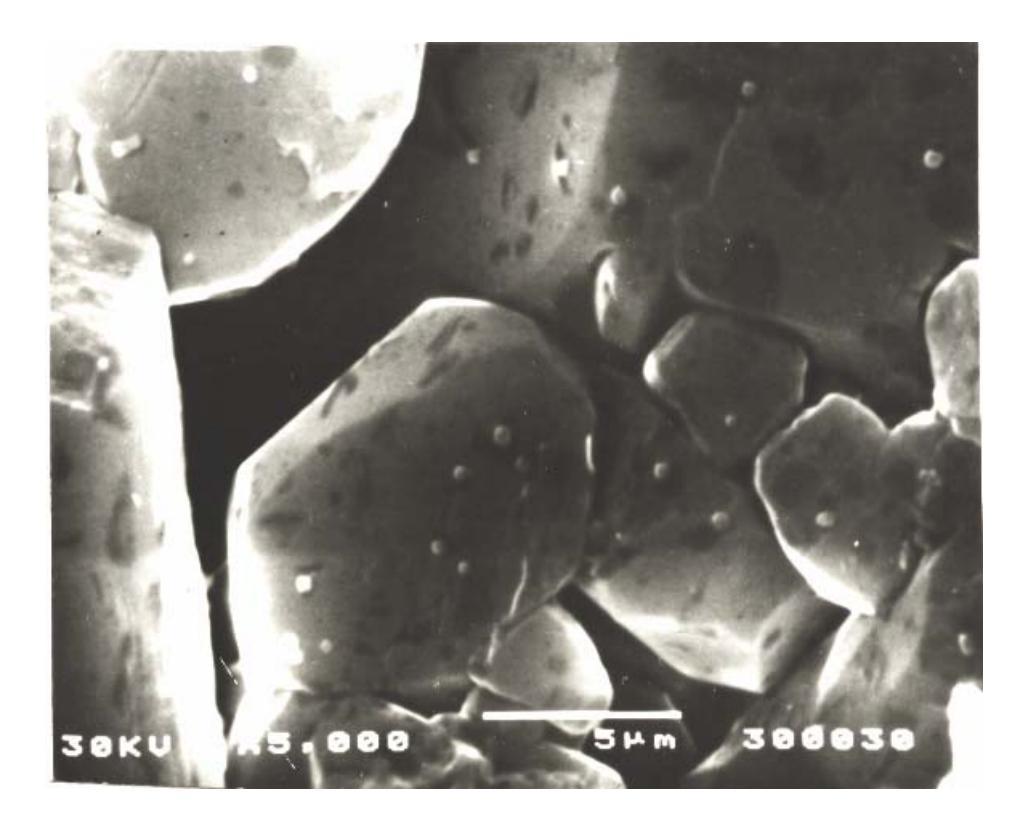
Further magnification on the damaged stone, figure 6, shows the surface of the calcite and dolomite crystals are clearly etched due to the effect of water.

Figure 6: The SEM of damaged stone showing the effect of water on the surface of calcite and dolomite crystals.
