Experimental Study of 3D Confined Masonry Building under Cyclic Loading

Abstract. Since the dawn of human civilization, masonry has been used to construct all types of buildings, bridges, roadways and other engineering works. Confined masonry (CM) is considered one of the popular forms of low-cost and low-rise construction throughout the world. Confined masonry consists of non-reinforced masonry walls surrounded by concrete tie-columns, in the vertical direction, and tie-beams, in the horizontal direction. In some countries confined masonry walls may include joint reinforcement. The behavior of constrained masonry structures under cyclic lateral loads was investigated in this experimental research. The two-story half-scale model was made using local materials and standards in consideration. With increasing displacement, lateral cyclic loads were applied to the model. Crack pattern, failure mechanism, lateral capacity, energy dissipation, ductility, and overall structural performance were all evaluated. Out of plane walls provided additional restrictions for wall movements and increased structural performance, while masonry infill walls provided significant strength and ductility.

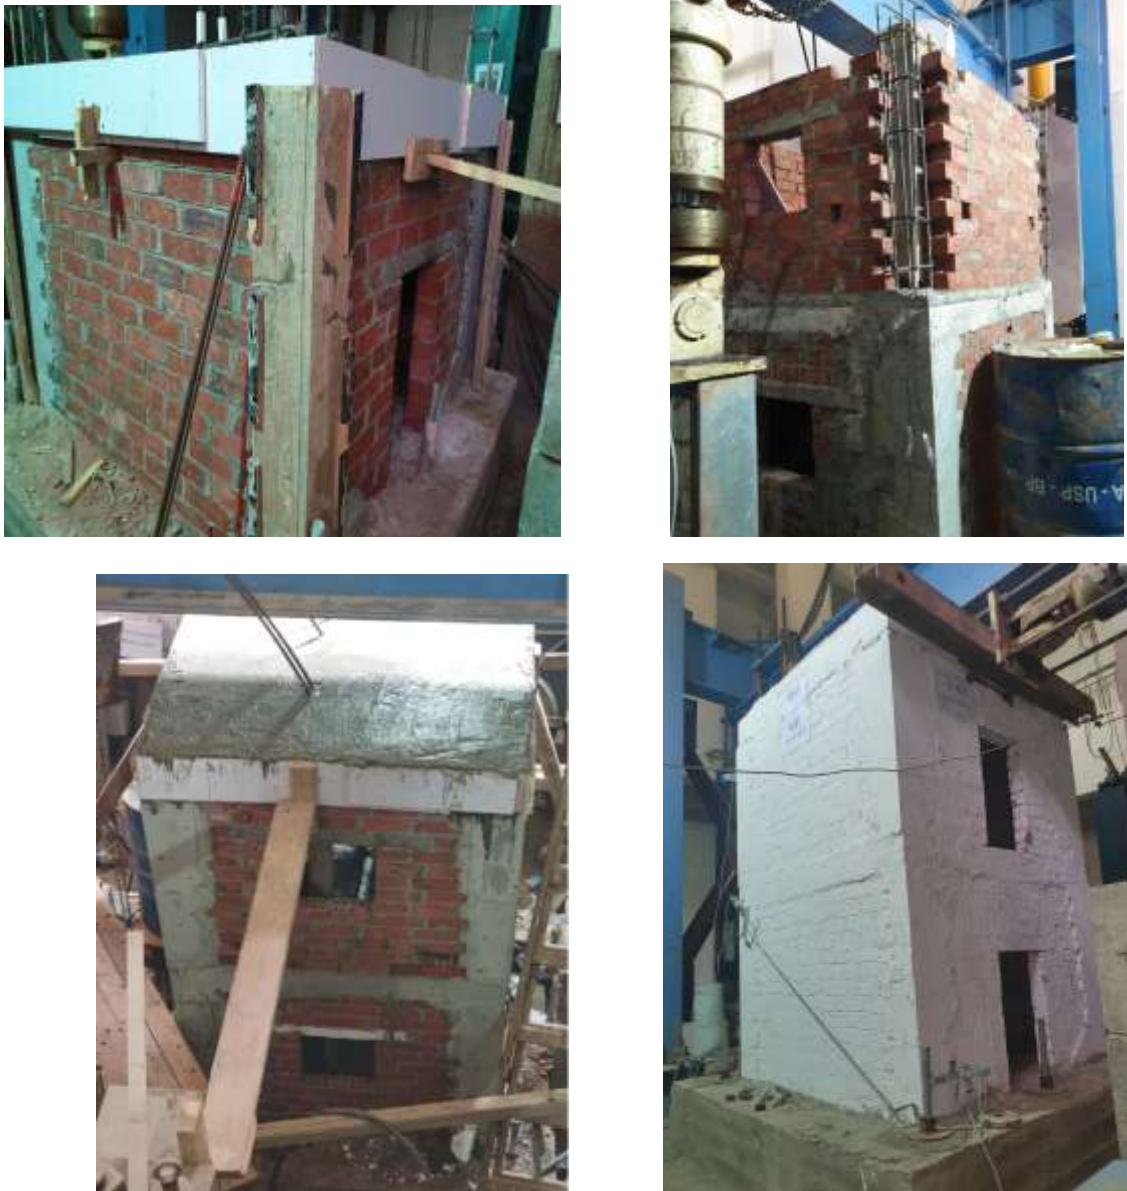
Fig.3. Construction process of specimen.

Construction of the specimen started with casting of RC raft to safely support each building. Steel RFT cage was initially formed with top and bottom layers of T12 @ 200 mm and fixed in position, followed by assembling a timber formwork surrounding the reinforcement steel cage. Three rows (spacing 0.80 m) of two strong pre-tensile bolts ($\varnothing 50$ mm) [located 1.6 m apart] were fixed at the form. Next, concrete with compressive strength of 25 MPa was poured manually into the formwork with concurrent consolidation using electric vibration.

An experienced mason built all masonry walls using the running bond pattern with 10 mm mortar bedding. Half bricks were deliberately left in alternate courses to create a toothed interlocking with tie-columns. Before setting up the formwork for tie-columns, multiple electrical steel strain gauges were glued on the longitudinal reinforcement. Formwork was then constructed for the tie-columns to maintain a size of 150x150 mm with a toothed interlocking with masonry wall and 15 mm clear concrete cover. Tie-columns were reinforced with 4T10 mm longitudinal bars and 6 mm diameter ties at 200 mm c/c. Next, formwork for the top slab and tie-beams was installed, followed by casting of concrete to a thickness of 150 mm. Concrete was then poured in the formwork and consolidated. Concrete was, then, cured after removal of formwork until the time of testing. Second floor was built according to the same procedure as the first storey. Work started with laying out masonry blocks to the required height. Afterwards, strain gauges were installed and tie-columns were casted followed by the tie-beams and top slab. Figure 3 shows a view during construction of the specimen. The specimen was painted with white pigment to allow for easy monitoring of cracking during the loading process.

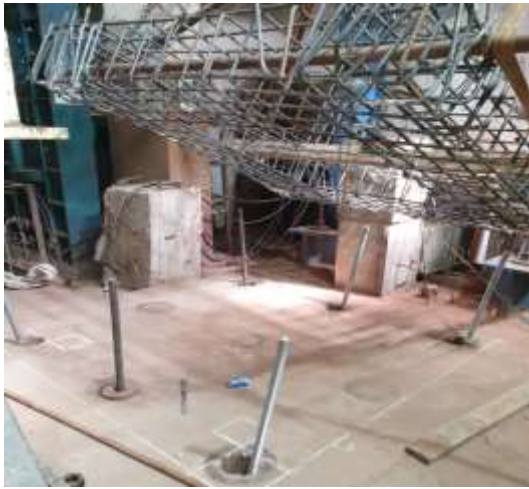
Fig. 4. Fixing the raft to the reaction floor.

As mentioned, raft of all CM buildings was fixed to the reaction floor by six $\text{Ø}50\text{mm}$ pre-tensile bolts (Figure 4) to prevent overturning and sliding of raft during the loading process.

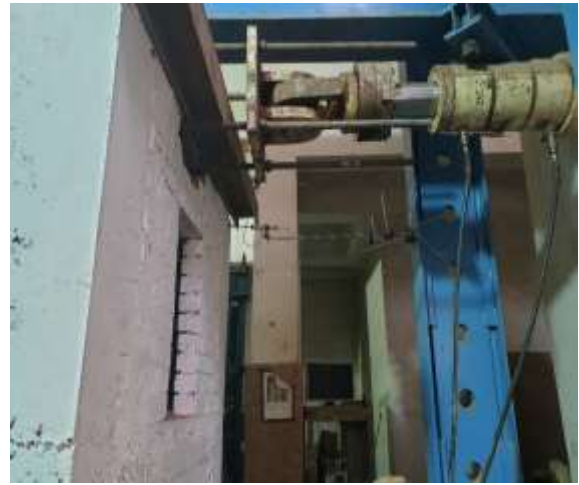
Fig 5. Hydraulic jack fixed at roof level.

The CM Building was subjected to a cyclic incremental lateral load until failure. Loading was applied using a 900 KN hydraulic actuator fixed at the roof level as shown in Figure 5, noting that a steel beam was added in between the jack plate and the finished surface of specimen to permit uniform loading at the roof level without localized fracture of building. The actuator works in two ways to permit reversed displacement-controlled loading. The horizontal hydraulic jack was connected to oil hydraulic pumps shown in Figure 6. The horizontal

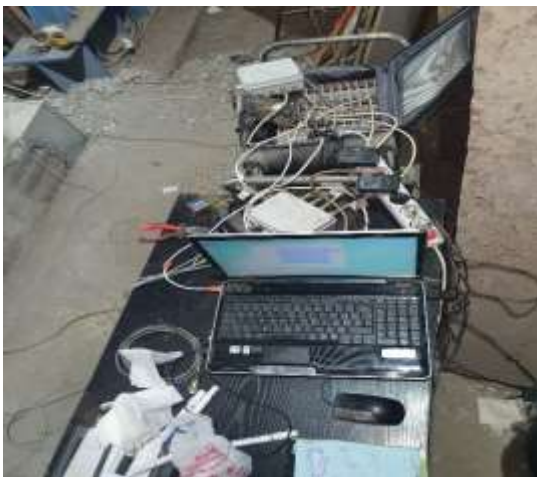
Fig. 8. Computer controlled data acquisition system.

was held constant for 2 minutes using a computer data acquisition system (Figure 8) to provide enough time for observing, identifying and measuring of visible cracks. The sample was oriented in such a way that loading was imposed perpendicular to the side of specimens with door perforations, as shown in (Figure 9). CM specimen was equipped with multiple electrical linear variable distance transducers (LVDTs) at key locations to measure displacements/strains of concrete and steel bars during loading. Six LVDTs were used with an accuracy of 0.01 mm and were coded LVDT-1 up to LVDT-6. Distance transducers were mounted on the two sides parallel to load direction; which were the two solid faces in locations as shown in Figure 10. LVDT-1 and LVDT-2 monitor the lateral displacement at the roof level point of the specimen, which represents the location of maximum expected lateral drift during loading. LVDT-3 senses any sliding of raft occurring during testing. The relative displacement between upper value measured by LVDT-1 or LVDT-2 and the sliding amount determined by LVDT-3 is considered the actual lateral displacement acting at the top of building, caused by the horizontal jack according to the cyclic displacement protocol adopted for testing. The purpose of LVDT-4 was to monitor any relative displacement occurring between the bottom point of masonry wall in first storey and the raft, which may occur if sliding and/or rocking failure modes were to control the failure of specimen. LVDTs 5 and 6 measured the diagonal crack width, occurring in the masonry panel for both push and pull directions. In addition, the described LVDTs aimed at monitoring the time history of master points of building to assist with continuous update of the specimen's geometry during the test.

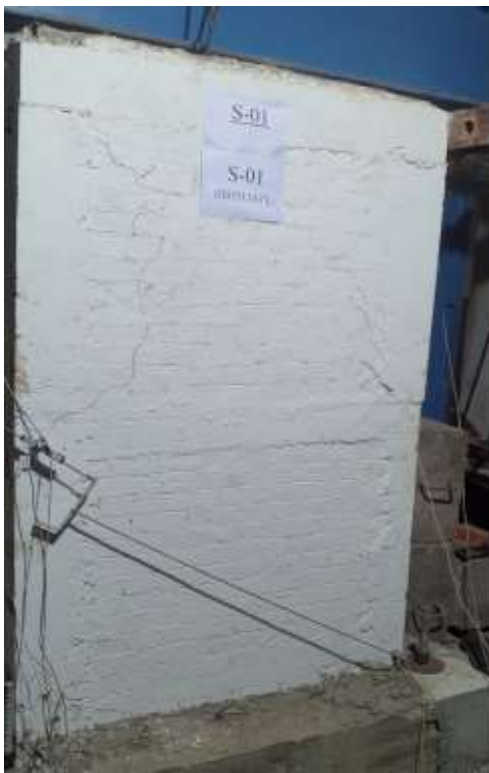
Damage state1 (DS1): In the push direction, the first visible crack appeared at a lateral displacement of 4.00 mm and corresponding lateral load of -70KN. The crack initiated at the bottom corner of upper floor in the front and back elevation (solid faces in this case) and propagated upwards until reaching three-quarters of the floor clear height. The crack started diagonally and then had a vertical orientation parallel the closest column at an average distance of 250 mm, suggesting the. Similarly, reversing the direction of loading (pull direction) caused the first crack to occur at lateral drift of 4.25 mm and corresponding lateral load of +80KN. However, the crack shape was diagonal starting from the bottom corner (opposite to the push direction) all the way up to the upper midpoint of walls, implying the shear failure behavior of walls. It should be noted that no signs of cracking were noticed for the two sides of specimen with perforations. In addition, for this loading range, no cracks were developed within the bottom storey since the upper floor was directly exposed to loading and experienced the maximum drift. Thus, most of the energy was absorbed by the elements of upper floor and accordingly, the damage was manifested in the form of the vertical/diagonal cracking. Figure 11 shows the final condition of specimen at the end of this loading stage.

Fig.11. DS1 first cracks at upper floor

| Damage state | Push | | Pull | | Cracks |
|---|---|---|---|---|---|
| DS1 | -70 | -4.0 | - | - | The appearance of an upper first crack under the beam of the second floor |

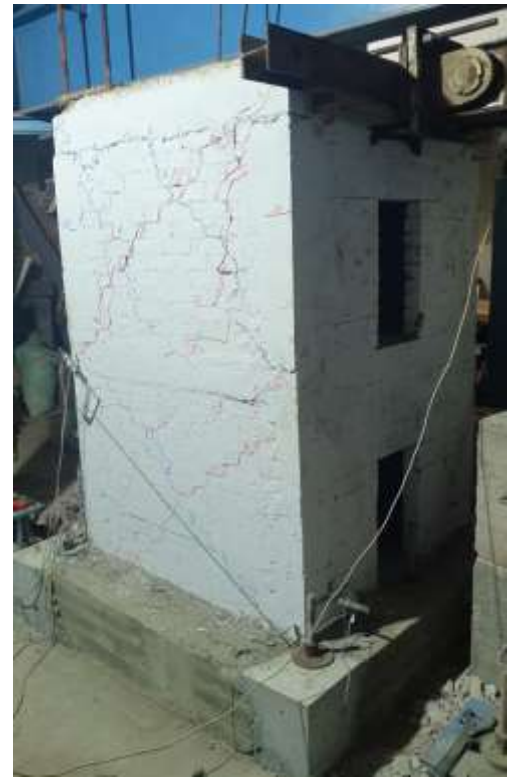
Damage state3 (DS3): During this stage of loading, the imposed lateral displacement was -8 mm and +4.5 mm in the push and pull directions, with a corresponding lateral loading of -110 KN and +100 KN, respectively. Pushing the specimens resulted in the development of a diagonal shear crack at the bottom corners of both floors (upper and bottom) reaching the opposite upper corners. In the pull direction, a diagonal crack initiated at the bottom corner of upper floor and propagated upwards up to the mid-point of tie-beam, with no noticeable cracks developed in the bottom floor. Generally,

the crack widths were slightly increased in this loading stage, as shown in Figure 12. Also, both sides perpendicular to the direction of loading remained intact without any signs of damage.

Fig. 12. DS3 Diagonal shear crack

| Damage state | Push | | Pull | | Cracks |
|---|---|---|---|---|---|
| DS3 | -110 | -8.0 | - | - | Diagonal shear crack |

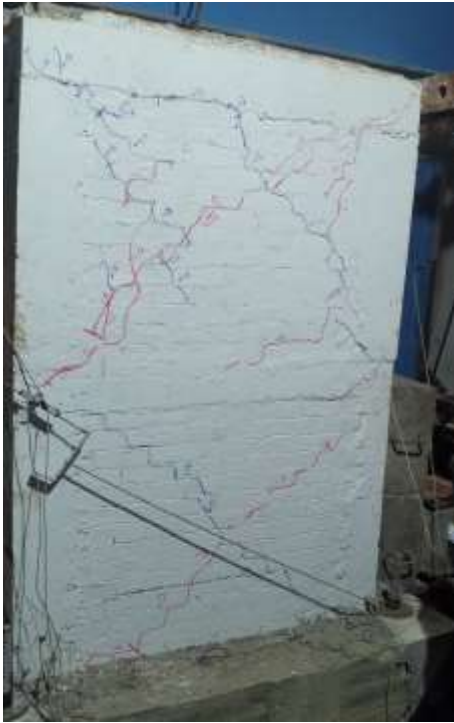
Damage state6 (DS6): At this stage, the imposed drift was 12 mm for both the push and pull directions with a corresponding lateral loading of 160 KN. The condition of the specimen at this stage of loading shows increased intensity of cracking in the upper floor. Horizontal cracks were developed at the bottom of tie-beam, as shown in Figure 13. In addition, the output cracks of previous stages propagated until the top corner of slab; also, widths of cracks were increased. For the bottom floor, a diagonal crack was developed in the pull direction between two opposite corner points, indicating the shear failure behavior of specimen. Also, a horizontal crack was noticed 250 mm above the top surface of foundation, which may refer to a flaw in the masonry units at this location of specimen. Regarding the sides with openings, few horizontal cracks were found around the locations of openings supposing the participation of those sides in the dissipation of energy after the sufficient cracking of solid walls; noting that, cracks were mainly horizontal due to tensile stresses developed at these points (i.e mortar beds due to the inability of masonry/mortar to support tensile stresses beyond their capacity) during the push and pull loadings.

Fig. 13. DS6 Propagated Diagonal Shear cracks

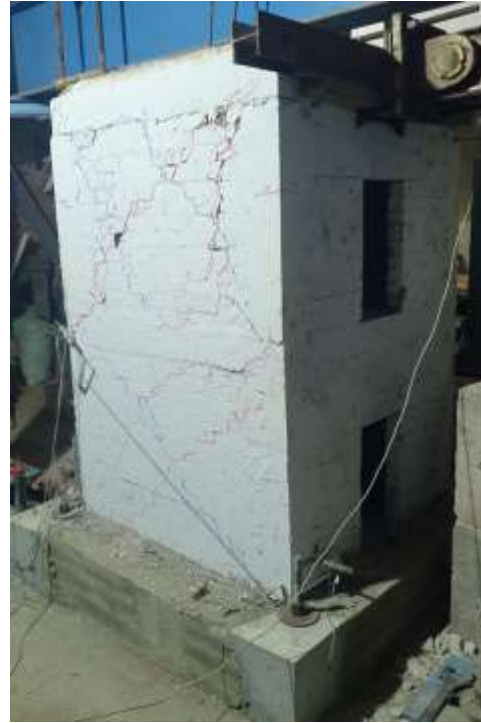
Damage state10 (DS10): Figure 14 shows the final condition of specimen at failure. The specimen could not sustain extra levels of loading. The specimen start to disintegrate and chunks of masonry fell from the upper storey. During this stage, the imposed lateral displacement was -26 mm for both the push and pull directions, with a corresponding lateral loading of -182 KN and +221 KN, respectively. The intensity of cracks significantly increased at this stage within the solid walls (main load resistant frames), especially for the upper floor due to its proximity to load. The final shape of cracks resembled a cross-mark for both top and bottoms floors, confirming the shear failure behavior of the specimen. No cracks were observed within the columns and foundation of specimen; nearly all cracks were formed within the masonry walls between the reinforced concrete elements, endorsing the benefits of infilled-masonry structures. Table 2 shows the damage stage of model specimen from DS1 to DS 10 until the specimen reached to failure.

Fig. 14 DS10 Diagonal shear crack at bottom

| Damage state | Push | | Pull | | Cracks |
|---|---|---|---|---|---|
| Ds10 | -182 | -26 | - | - | Failure Shear diagonal at top level |

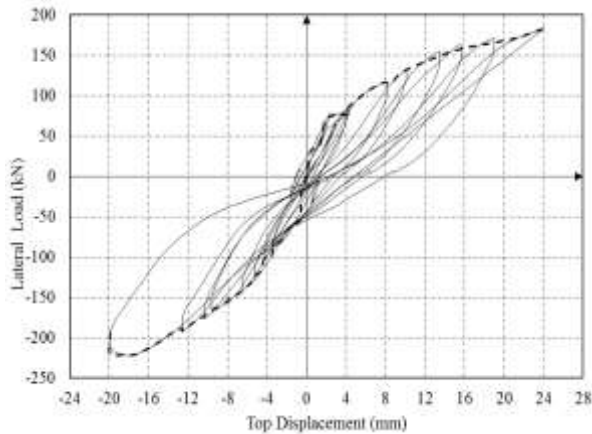
Fig. 15. Hysteresis loops and Envelope curve

The relative Hysteresis loops and Envelope curve for the 3D model assembly sample are shown in Figure 15 as the solid lines indicate to load-displacement relationship for each cycle, and the bold dashed line indicates to envelope curve that connect the end values of cycles. The figure indicates that initial stiffness of specimen was high so the initial relative loads for small displacements were great. After the first crack in pushing side appeared, the stiffness was reduced with increasing top displacement. The maximum lateral load was +182 KN relative to +22 mm lateral top displacement and -221KN relative to -20mm top displacement.

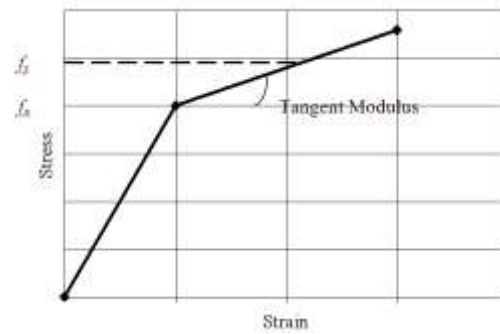
Fig. 23. Modeling of Steel Using Bilinear Kinematic Hardening

In modeling of steel reinforcement, the stress-strain connection is represented by two straight lines, as provided by Taijum Wang [2001]. Figure 23 shows the average stress-strain curve of steel bars implanted in concrete

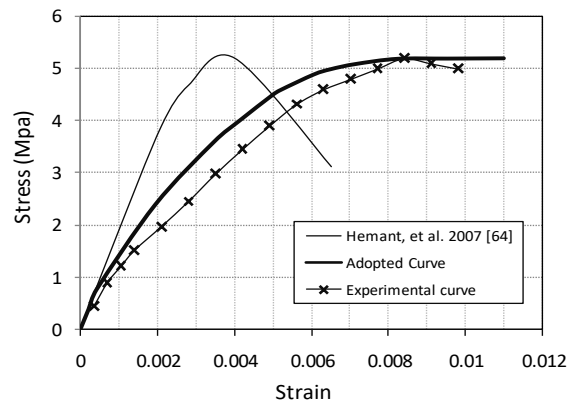
Fig. 24. Compressive stress-strain curves for masonry

Eight masonry prisms were tested in order to evaluate the mechanical properties (masonry characteristic compressive strength f_m), these tests were performed to evaluate the stress-strain curve for masonry constructed from units available in the local Egyptian market. Although many curves can really be found in text books and other references (Hemant, et al. 2007 [14]), Figure 24 depicts the experimental, reference, and adopted curves, with the adopted curve able to anticipate the failure load and load displacement curve with acceptable accuracy.

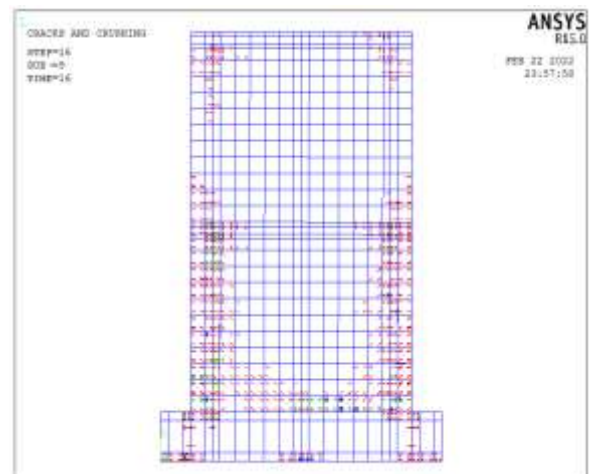
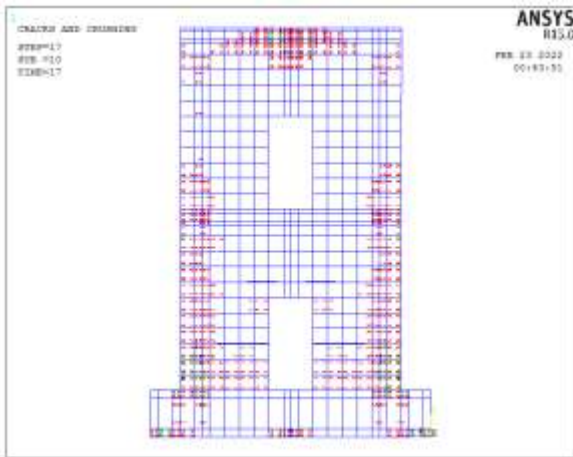
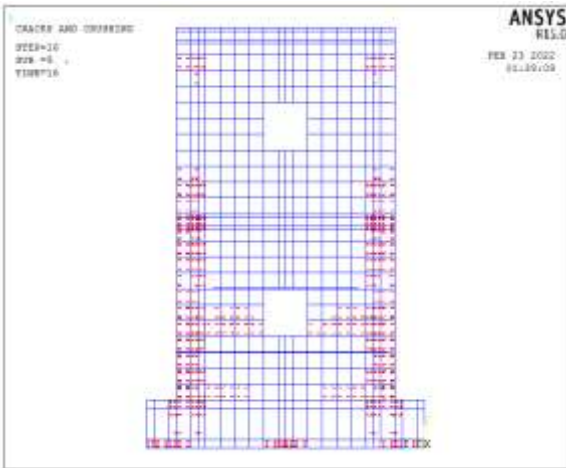
Figures 26a to 26i show the cracking patterns obtained from finite element model at cracking load, at maximum load, and finally at ultimate or failure load which can be acceptable with good agreements with compared to cracking patterns of experimental test.

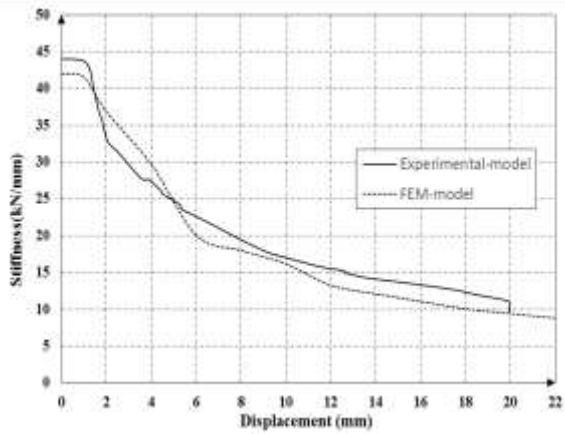
curve is shown in Figure 28c, the initial stiffness of FEM model about 95% of its value of experimental model. The relative cumulative Energy Dissipation curve is shown in Figure 28d. The Total cumulative dissipated energy at end of result were 7.2KN.m and 4.0KN.m at ultimate displacement equals +22.0mm.

Fig. 28.C. Stiffness curves for experimental and finite model.
