## Case Studies in Construction Materials

## Case study

## Experimental behavior of full-scale exterior beam-column space joints retrofitted by ferrocement layers under cyclic loading

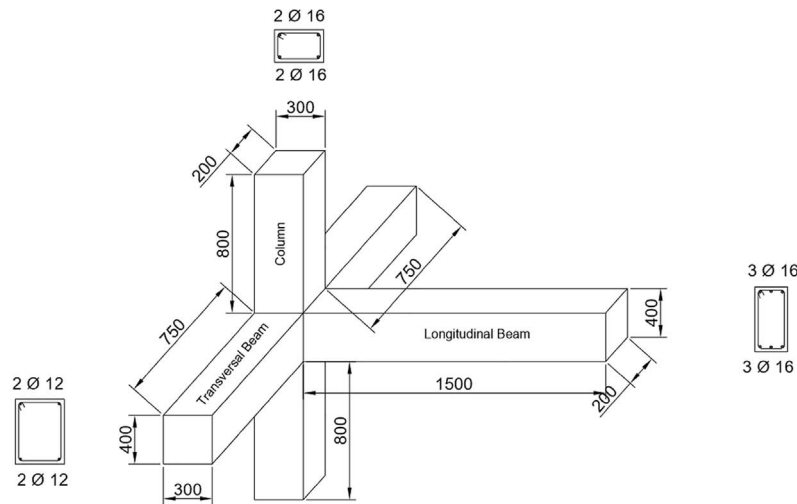
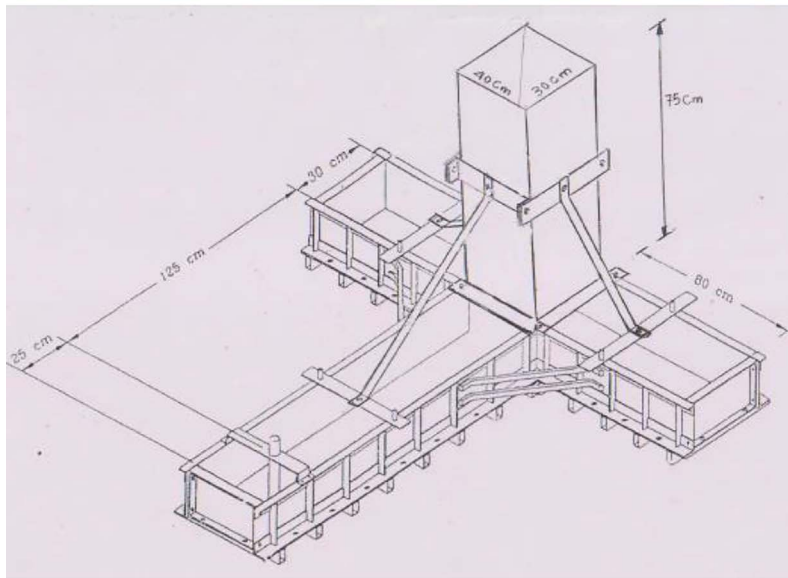
Fig. 1. Schematic diagrams for test specimens and formwork.

(a) Specimen dimensions (mm)

(b) Formwork shape and dimensions

The experimental program consisted of eleven beam-column space joints subjected to cyclic loading. The test specimens simulate exterior beam-column space joints in a multistory building. The beam length represents half the span length of the bay, while the column height represents the column height from the mid height of one story to the mid height of the next one. The boundary conditions are set to simulate the point of contra-flexure in the beams and the column with an acceptable accuracy. Fig. 1 and Table 1 show dimensions and details of test specimens and the used formwork. One of the eleven specimens was designed and detailed according to ACI 318 [18] (control specimen) while the other ten specimens were designed and detailed according to a detail used traditionally in Egypt and several countries in the middle east to carry gravity loads only without any precautions for lateral loads caused by earthquakes (see Figs. 2 and 3). Ferrocement jackets of different layers and different orientation angles of expanded wire mesh reinforcement beside the steel angles were used for strengthening nine of the ten test specimens with traditional reinforcement while the tenth was left without strengthening to be considered as a control specimen along with the beam detailed to ACI 318 [18] (see Table 1 and Fig. 4).

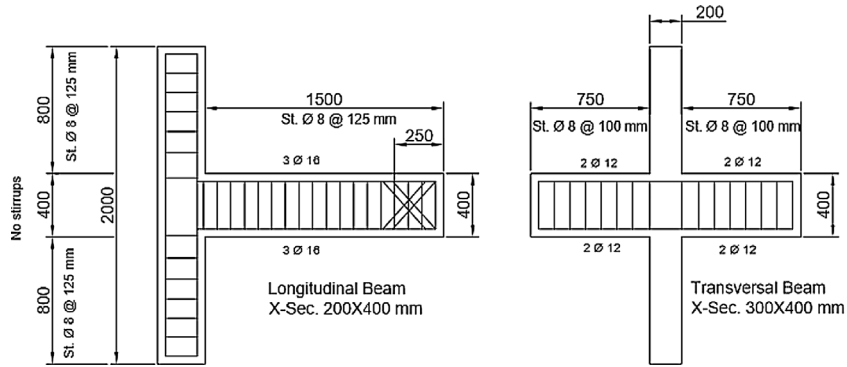
Fig. 2. Reinforcement details of a beam-column joint without adequate shear reinforcement (less confinement), REJ1.

compared to Specimen REJ1 (see Fig. 2). Qudah and Maalej [11] recorded similar observations in their study for application of engineered cementitious composites (ECC) in beam–column joints for enhanced seismic resistance.

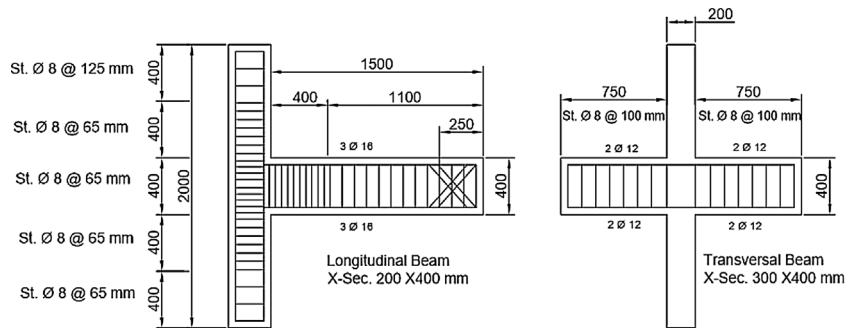
Fig. 3. Reinforcement details of beam-column joint according to ACI requirements REJ2.

The sequence of cracks initiation and propagation for Specimen REJ1 along the amplitudes of displacement is shown in Fig. 10(a). It was noticed that the flexural cracks initiated in the top and the bottom fibers of the beam at the first cycle of loading. Inclined and vertical cracks were developed in the beam between the loading point and the beam-column interface. By further displacement application, the length of previously established cracks was increased and new vertical cracks were formed near to the beam-column interface. The same behavior continued up to a displacement of 20 mm. In the subsequent cycles, the inclined cracks around the beam-column interface lengthened and joined to the vertical crack. The major vertical crack appeared in the back face of the joint. At the onset of the peak load attainment, the vertical crack widened and a part of concrete cover around this crack started spalling off with a rapid loss of load carrying capacity. The mode of failure of Specimen REJ1 was flexural shear failure in the beam near to the beam-column interface. This is similar to the findings of Qudah and Maalej [11]. Successive cracking patterns and corresponding displacement for Specimen REJ2 were shown in Fig. 10(b). Similar to REJ1, flexural shear cracks were initiated in the top and the bottom of the beam. Inclined cracks continued building up between 2 mm and 8 mm displacement with no existence of joint or column cracks. At displacement amplitude of 16 mm, few hairline cracks appeared in the column and out of plane beam near to the joint zone. At the ultimate load attainment, the beam shear cracks were fully developed and inclined beam cracks lengthened and widened. A major vertical crack was observed at the beam-column interface; further loading resulted in a gradual building up of cracks accompanied by continuous drop of the load carrying capacity without any spalling of the concrete cover. The mode of failure of Specimen REJ2 was flexural failure in the beam close to the joint region and did not suffer heavily damage as observed for REJ1 joint. It can be argued that there was adequate shear reinforcement in the joint region and in the beam for Specimen REJ2 (see Fig. 3)

recorded in Table 2, show clearly that the order of improvement in the behavior was as follows; EJANG3, EJANG2, EJ3, EJANG1, EJ6, REJ2, EJ2, EJ5, EJ1, EJ4, compared to the reference specimen with insufficient reinforcement, REJ1. The details of the specimens explained in Table 1 and shown in Figs. 2–4 may explain such improvement. It was noticed that the specimen REJ2 attained its strength constant for more cycles compared to REJ1 below the ultimate load. Although REJ1 and REJ2 have the same flexure steel reinforcement (Figs. 2 and 3), it is easily concluded that the difference in behavior is due to the confinement achieved in REJ2 by the addition of transverse reinforcement (Fig. 3).

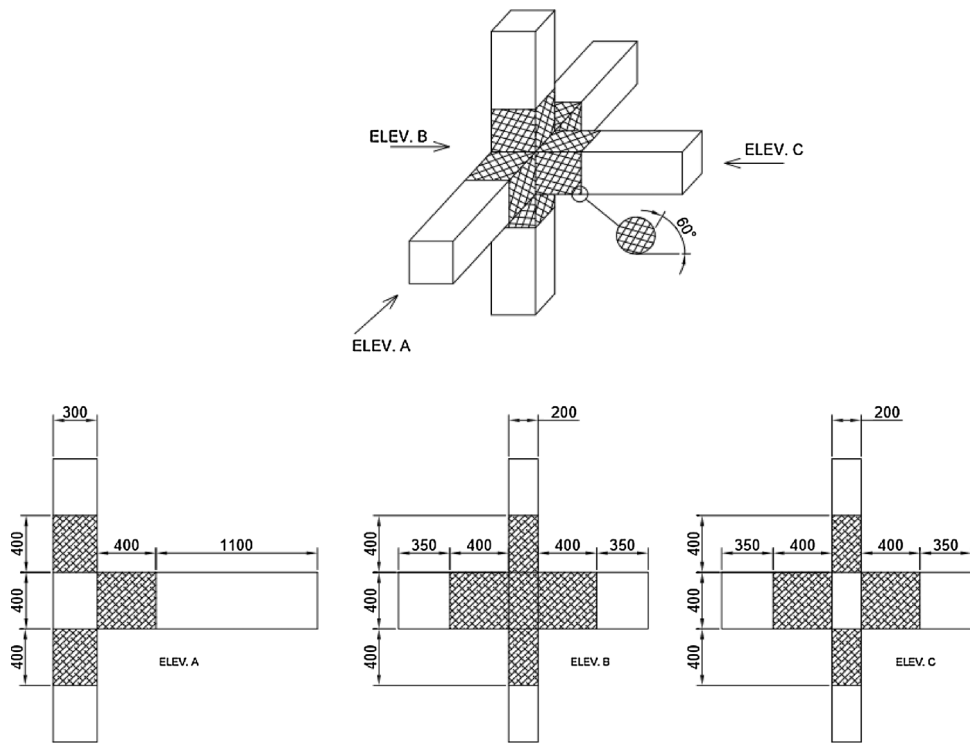
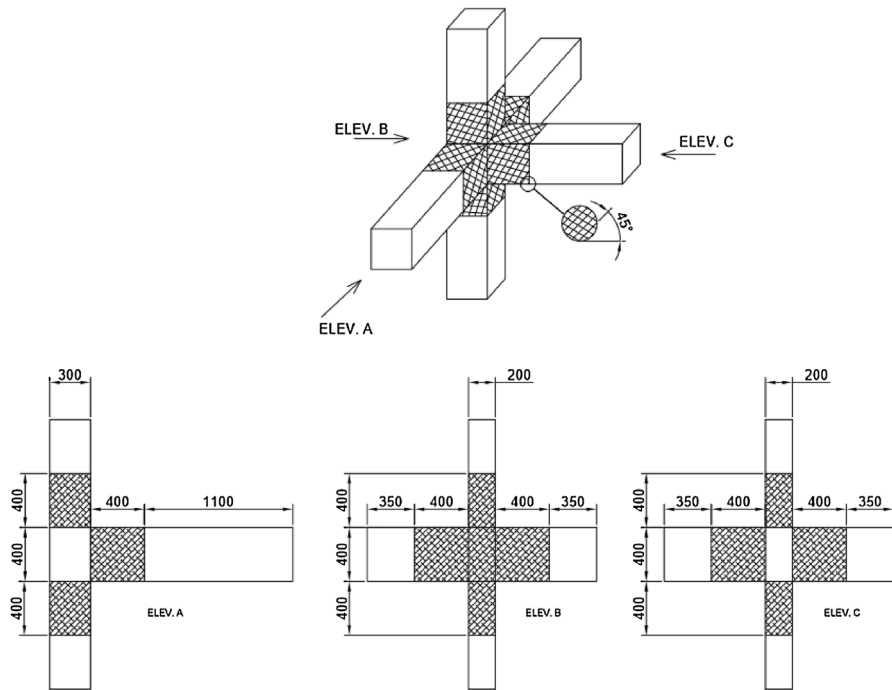
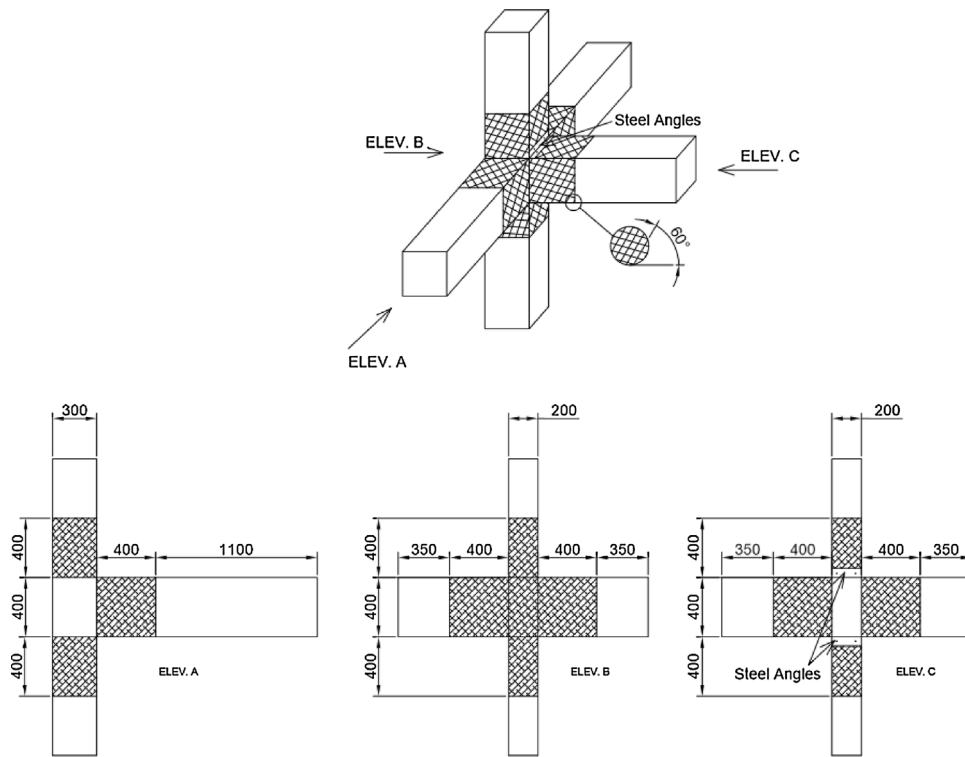
Fig. 4. Schematic diagram for ferrocement layers of different orientation angles around studied space joints (see Table 1).

(a) Joints EJ1, EJ2, and EJ3

(b) Joints EJ4, EJ5, and EJ6

(c) Joints EJANG1, EJANG2, and EJANG3

retrofitting using steel angles 50\*50\*5 mm at the top and at the bottom fibers of the loaded beam in addition to the ferrocement layers (see Fig. 4(c)). It is worth mentioning that the surface preparation process of specimens is the most critical phase of retrofitting which needs proper understanding and care to meet the necessary requirements for retrofitting. In addition, good training is necessary for applying this technique in site for real structural joints.

Retrofitting specimens by ferrocement layers of orientation angle,  $60^\circ$ , in addition to steel angles in corners of the joint (as shown in Fig. 4(c)), showed further improvement in the behavior of such specimens, EJANG1, EJANG2 and EJANG3 compared to traditionally reinforced specimen without adequate confinement, REJ1, to different degrees. However, the behavior of specimens retrofitted by higher number of ferrocement layers is better than that retrofitting by less number of layers in the presence of stiffening by steel angles. For example, the behavior of EJ3 was better than that of EJANG1 in terms of attaining higher ultimate load and longer displacement until failure. Table 2 indicates that specimen, EJANG3, had the best performance among the other specimens. It had a maximum load of 10.04 ton in push and 9.18 ton in pull and the specimen failed in 59 mm displacement. Table 2 shows also that the properly confined specimen according to ACI 318, REJ2, attained higher ultimate loads than that of some of the retrofitted specimens such as EJ1, EJ4, EJ5, and EJ6. It can be argued that proper reinforcement of the beam-column joints according to codes of practice may be even structurally better than retrofitting of such joints. It was also noticed that using two layers or higher of ferrocement achieved significant improvement in capacity and ductility of retrofitted specimens, and adding steel angles in the corner of the joint

to the developed cracks for the REJ1 specimen (see Figs. 4 (a), 6 and 10 (a)). In addition, the adequate shear reinforcement for the joint region from the start (REJ2) may be better than the repair and retrofitting of beam-column joints, which were not properly reinforced against lateral loads, REJ1.

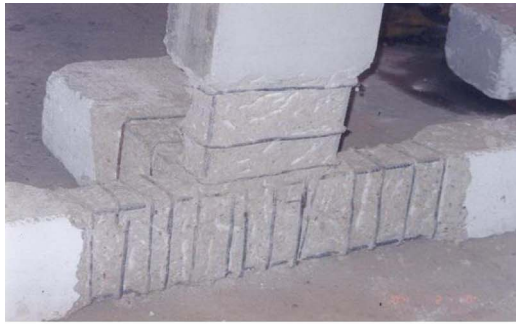
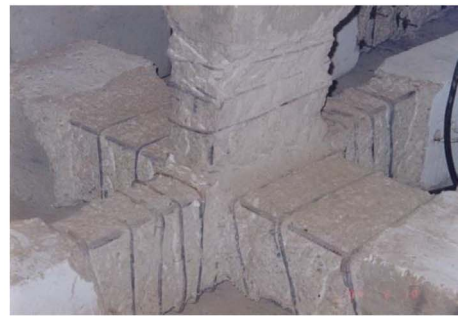
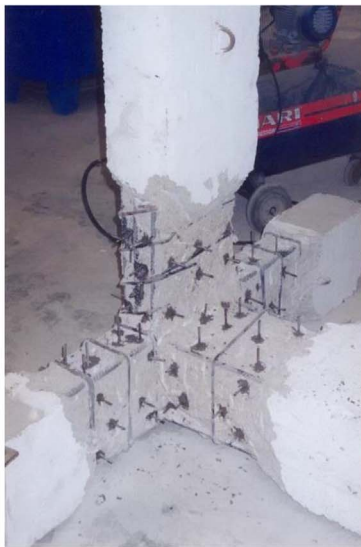
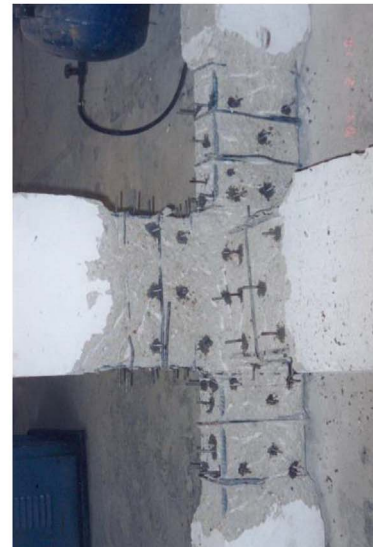
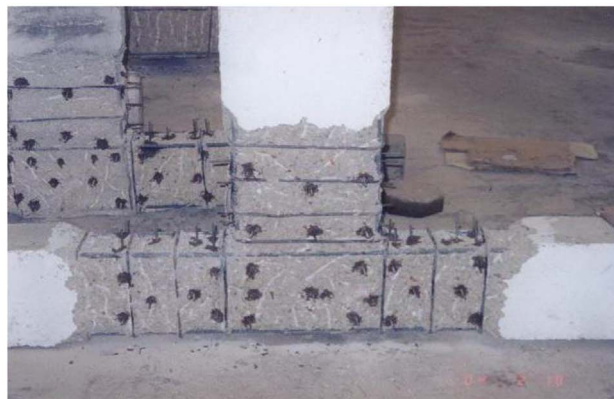
(a) Removing the concrete cover for beams and column

(b) Drilling holes and inserting steel dowels

Fig. 5. Removing concrete cover and inserting steel dowels to ensure composite action between the ferrocement layers and concrete core.

After 28 days, the concrete cover around the joint was removed for the nine exterior specimens using a small hand-held chipping hammer. The removed cover extends 300 mm in the beam and 300 mm in the column above and below the joint. The surface of steel reinforcement was exposed and cleaned (see Fig. 5(a)). The edges of the removed cover were kept curved and roughened to prevent stress concentration. For the specimens prepared for retrofitting, staggered holes were drilled in each specimen in predefined locations (10–15 cm apart) as shown in Fig. 5(b) and (c). Each hole of diameter 8 mm penetrated the core with 50 mm depth. The inner surfaces of the holes were roughened and cleaned from loose concrete pieces and dust using compressed air. The mixed anchoring grout was poured steadily into holes and a 6 mm galvanized high strength threaded bars (steel dowels) were inserted inside the holes to ensure composite action between the ferrocement layer and concrete core (see Fig. 5). The retrofitted specimens were wrapped by one layer of wire mesh (with overlap of 100 mm) as shown in Fig. 6. The expanded wire mesh was fixed to the embedded 6 mm, shear connectors by washers and nuts. The strengthened specimens were plastered with a thin layer of rich cement mortar (650 kg of Portland cement per  $1\text{m}^3$  of well graded sand with 0.4 as water cement ratio). The wrapped specimen was cured by water for 4 days. The same process was repeated for each layer of ferrocement. The specimens EJANG1, EJANG2, and EJANG3 were

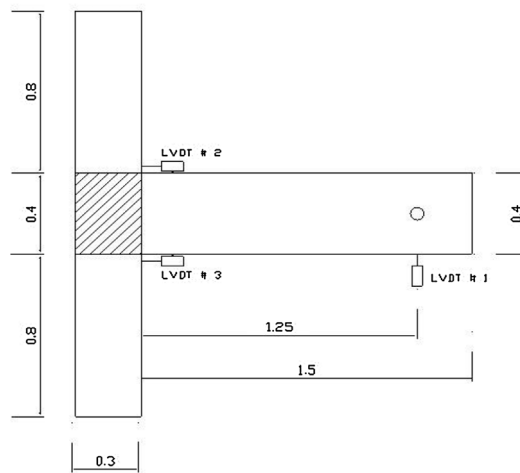
(c) LVDTs location at concrete surface

Fig. 7. Location of strain gauges (for steel) and LVDTs (for concrete).

Electrical strain gauges were adhered to the reinforcing bars of specimens at appropriate locations (see Fig. 7(a) and (b)). Linear voltage differential transducers (LVDTs) were used to measure the various types of deformations of the beam-column sub assemblage (see Fig. 7(c)). For all specimens, the loading was controlled by the displacement of the beam at the intended loading point. An axial load equals to 0.5 ultimate load of the column was applied to the column and kept constant throughout the test. Reversed cyclic displacements were applied to the free end of the beam simulating an earthquake-type loading. The same process was repeated for

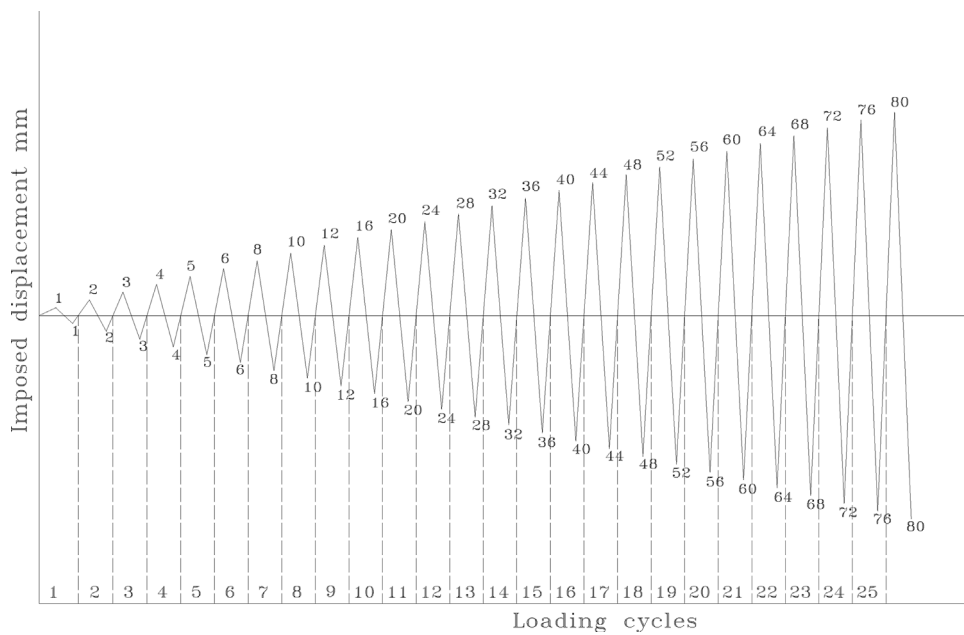
Fig. 8. Cyclic load history.

each cycle. The used displacement controlled loading history is shown in Fig. 8, the testing frame and testing process are shown in Fig. 9. This loading schedule discloses information on both strength and stiffness degradation of the specimen. Although the applied displacements in the later cycle of the proposed loading history may violate the code provision which limit the story drift, the use of such a loading history was justified in order to obtain as much information as possible about the behavior of each specimen. All the data gathered from load cells, displacement transducers, and strain gauges were recorded continuously during the test by computer controlled data acquisition system. Cracks were observed and traced for each load level.

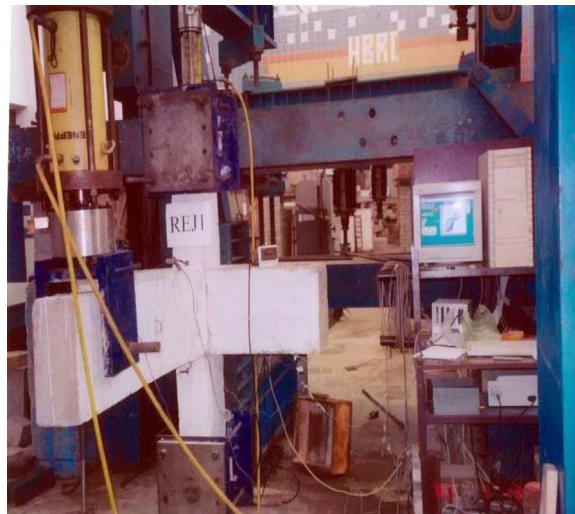
Fig. 9. Testing frame and testing process.

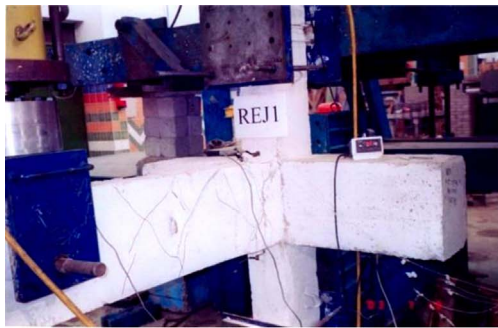
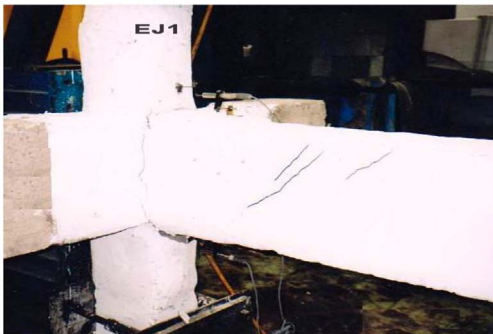
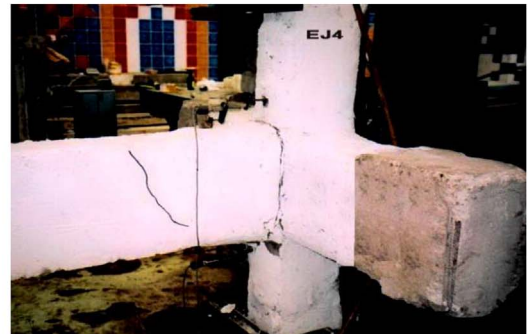
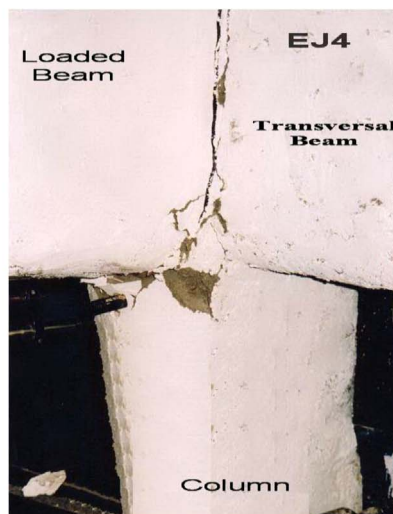
Fig. 10. Crack pattern and mode of failure for selected specimens before and after retrofitting.

It was observed that the general crack patterns and mode of failure for the retrofitted specimens either those retrofitted by different layers of ferrocement (with different orientation angles) or by combined action of ferrocement jackets and steel angles anchored at the beam-column interface were almost similar. However, the crack initiation and propagation delayed and a less

number of diagonal shear cracks was observed for specimens retrofitted by combined action of ferrocement jackets and steel angles. In addition, orientation angle of expanded wire mesh has some effect on the initiation and propagation of the cracks without changing the mode of failure. For example, Fig. 10(c)–(e) shows the crack patterns for typical specimens, EJ1, retrofitted by one layer of ferrocement of expanded wire mesh of orientation angle  $60^\circ$ , and EJ4, retrofitted by one layer of ferrocement of expanded wire mesh of orientation angle  $45^\circ$ . Retrofitting using ferrocement enhanced the confinement, delayed the cracks formation, decreased the cracks propagation and ultimately increased the capacity of the joint. Inclined hairline cracks were first observed at the top and bottom fibers of the beam near the ferrocement jacket far edge at the second or third cycle of loading. With increasing the load levels, the length of these inclined cracks of the beam increased and widened. New hairline cracks appeared in the strengthened zone of the beam. A vertical crack at the beam-column interface in both front and back face of the beam was developed and widened onset the ultimate load attainment. At the end of the test, it was clear that the vertical crack at beam-column interface lengthened, widened, and surrounded the beam cross section causing local peeling of the ferrocement outer layer. The mode of failure of the strengthened specimen was flexural in the beam close to the beam-column interface (see Fig. 10(d) and (e)). This mode of failure is very close to that observed by Ravichandran and Jeyasehar [2] and Kannan et al. [20] while the mode of failure of strengthened beam-column joints using steel jackets was flexural failure at the far edge of steel plates [12].

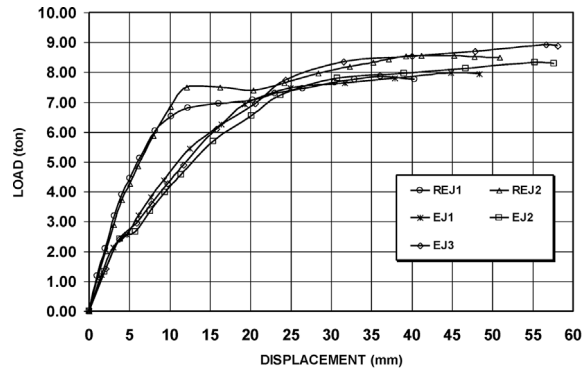
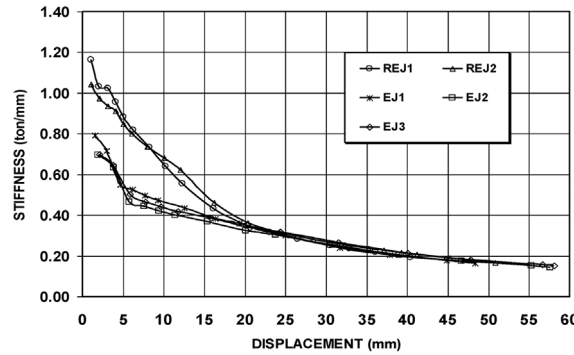
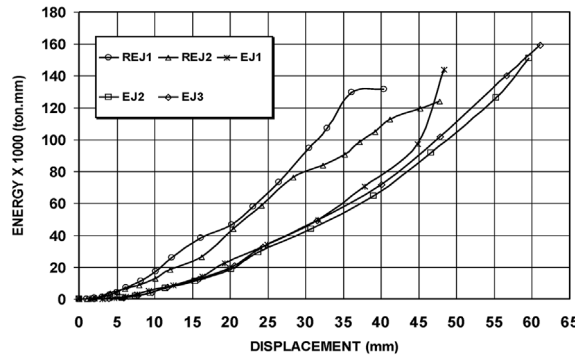
(a) Strength envelopes

(b) Secant stiffness degradation

(c) Cumulative hysteretic energy

Fig. 11. Strength decay, stiffness degradation and energy dissipation for specimens retrofitted by ferrocement layers of orientation angle 60°

**3.3.1.1. Strength envelopes.** Fig. 11 (a) shows the load displacement relationship for the reference specimens REJ1, REJ2 and the specimens retrofitted by different ferrocement layers of orientation angle of 60° for the expanded wire mesh. It can be seen from the figure that the reference specimens show higher load than that of the retrofitted specimens at the start of cyclic loading until 12 mm displacement. After the displacement reaches 20 mm, the reference specimens and the ones retrofitted by ferrocement layers followed the same trend. The ultimate load capacity of the ACI detailed joint with sufficient shear reinforcement (good confinement), REJ2 was 8–10% higher than that of the traditionally reinforced joint REJ1 (see Table 2). Fig. 11(a) and Table 2 show that the load carrying capacity is directly proportional to the number of ferrocement layers used for strengthening. For example, the ultimate load capacity of EJ1, EJ2, and EJ3 was higher than that of REJ1 by 3.30%, 7.60%, and 15.20%, respectively. This may be attributed to the confinement enhanced by wrapping the specimens with ferrocement layers and the composite action achieved by attaching such layers to the retrofitted specimen using the shear dowels (see Figs. 5 and 6). It can be seen also that EJ1 had lower ultimate load than that of the ACI detailed joint, REJ2, while using two ferrocement layers for retrofitting, EJ2, led to an ultimate load almost similar to that of REJ2 and its ultimate displacement to failure was higher than that of REJ2 by 7% only. Increasing the number of ferrocement layers to three led to a further improvement in the ultimate capacity of Joint EJ3 over that of REJ2 (almost double as much the improvement achieved by retrofitting with two layers, Joint EJ2). It was observed that such improvement is less than that obtained by Ravichandran and Jeyasehar [2], Li et al. [9], Kannan et al. [20] and Seoud [4]. It can be argued that the exterior joints in the current research, included transversal beams to simulate the real joints in actual building reduce the effect of confinement using ferrocement layers compared with these studies in the literature.

**3.3.1.2. Stiffness degradation and energy dissipation capacity.** The stiffness degradation and energy dissipation capacity for Specimens EJ1, EJ2, EJ3, REJ1, and REJ2 are reported in Tables 3 and 4 and the graphs are presented in Fig. 11(b) and (c), respectively. Fig. 11(b) shows that the stiffness degradation for reference specimens REJ1 and REJ2 was sharper than that of the retrofitted specimens at the beginning until the displacement reaches 20 mm and then all the specimens followed the same trend as was

observed for strength envelopes (see Fig. 11(a)). After 20 mm displacement, the stiffness degradation decreased with increasing ferrocement layers because of the significant confinement of the joint core since the ferrocement layers substitute the inadequate shear reinforcement in the joint region. Fig. 11(c) shows that the cumulative dissipated energy differentiates clearly between the reference specimens and those retrofitted by ferrocement layers. It can be seen also that the relationships indicated that the strengthened exterior joints with more ferrocement layers attained higher capacity of the dissipated energy. Table 4 and Fig. 11(c) show that Joints EJ1, EJ2 and EJ3 attained higher accumulated capacity of the dissipated energy than the reference traditional Joint REJ1 while the reference ACI detailed Joint REJ2 attained higher cumulative dissipated energy than that of EJ1. The figure and the table show also that the energy dissipation capacity of EJ3, retrofitted by three ferrocement layers was slightly higher than that of EJ2, retrofitted by two layers of ferrocement. Fig. 11(b), (c), Tables 3 and 4 show that Joint EJ1, retrofitted by one ferrocement layer showed stiffness degradation and cumulated dissipated energy lower than that of REJ2.

REJ2. It was observed that the ultimate load of EJ4 was less than that of the ACI detailed joint REJ2 and slightly lower than that of EJ1 (see Fig. 11(a) and Table 2). In addition, the ultimate load of EJ4 was almost the same as that of REJ1; however, it resisted a higher number of cycles prior to failure and its ultimate displacement was higher than that of REJ1 by 14%. This indicates that even that the enhancement in ultimate capacity for specimens retrofitted by ferrocement layers of orientation angle equals 45° was less than that for those having orientation angle 60°, the retrofitting itself enhances the ultimate displacement prior to failure which indicates the ductility of specimens (see Table 2). Table 2 and Fig. 12(a) show that increasing the number of layers led to an improvement of the ultimate capacity of the specimens but still to a lower degree compared with that of orientation angle 60°. Figs. 11 (a) and 15(a) show that the ultimate load capacities of EJ2, EJ5, EJ3 and EJ6 were higher than that of REJ1 by 7.60%, 4.30%, 15.20% and 7.5% while the ultimate load capacity of the ACI detailed space Joint REJ2 was 8.90% higher than that of the local Joint, REJ1. This shows that the improvement of specimens retrofitted by two and three layers of ferrocement with expanded wire mesh orientation, 60°, was higher than that of those retrofitted by two or three layers of wire mesh orientation, 45°. This may be attributed to the geometrical shape of the wire mesh, which makes its main reinforcement direction for 60° orientation, is almost perpendicular

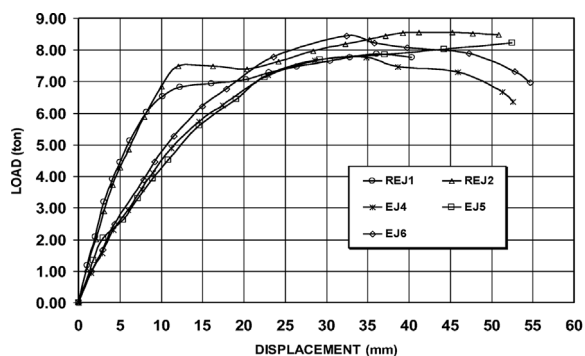
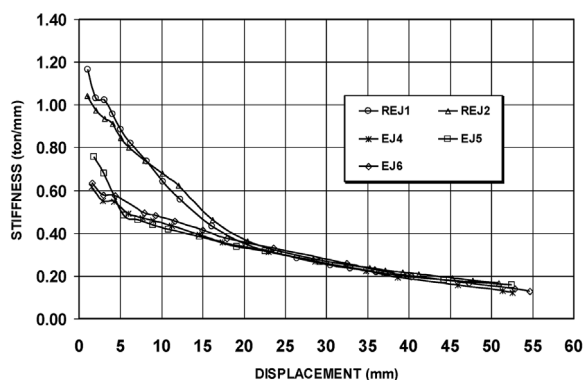
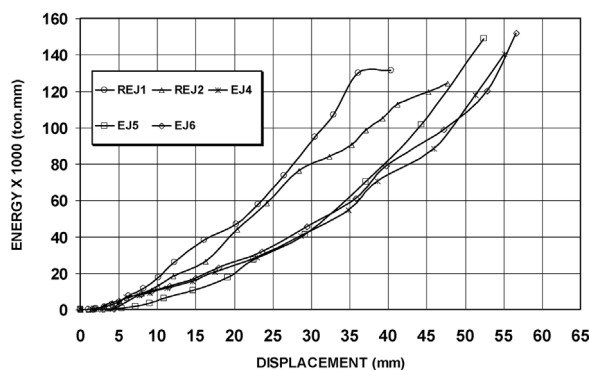
(a) Strength envelopes

(b) Secant stiffness degradation

(c) Cumulative hysteretic energy

Fig. 12. Strength decay, stiffness degradation and energy dissipation for specimens retrofitted by ferrocement layers of orientation angle 45°.

3.3.2.1. Strength envelopes. Fig. 12(a) shows the load carrying capacity versus displacement for the specimens retrofitted by ferrocement layers of expanded wire mesh orientation angle, 45°, EJ4, EJ5, and EJ6, besides the two reference samples REJ1, and

3.3.2.2. *Stiffness degradation and energy dissipation capacity.* The effect of orientation angle and confinement provided by the ferrocement layers can be observed in the stiffness degradation and energy dissipation capacity curves for upper mentioned specimens EJ4, EJ5, EJ6, REJ1, and REJ2 plotted in Fig. 12(b) and (c), respectively. The results are also reported in Tables 3 and 4. It can be seen from the figures that the specimens retrofitted by ferrocement layers of orientation angle 45° showed almost a similar trend as shown for specimens retrofitted by ferrocement layers of orientation angle 60° (see Fig. 11(b) and (c)) in terms of experiencing a uniform pattern of stiffness degradation and cumulative energy dissipation. However, specimens wrapped by ferrocement layers of orientation angle 60°, showed a better behavior in terms of attaining slightly higher accumulated capacity of the dissipated energy and slightly lower stiffness degradation than that of the specimens retrofitted by ferrocement layers of orientation 45°, especially in the late stages (see Tables 3 and 4).

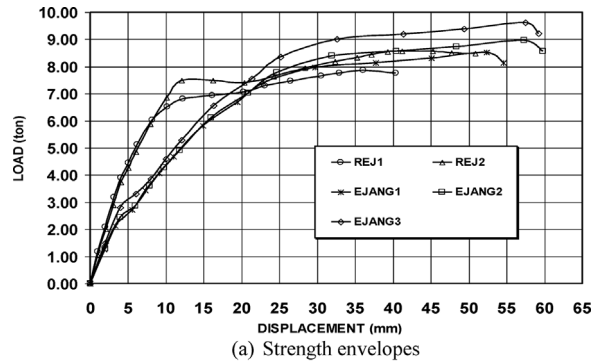
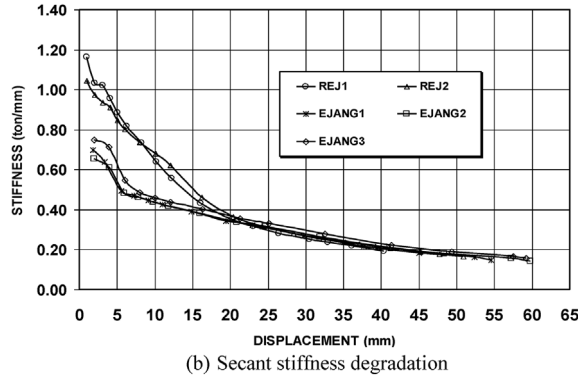
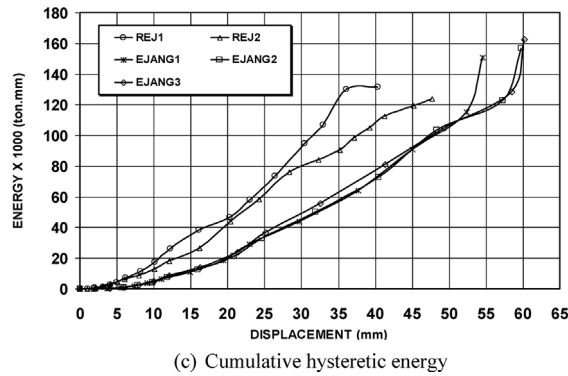
Fig. 13. Strength decay, stiffness degradation and energy dissipation for specimens retrofitted by ferrocement layers (orientation angle 60°) and steel angles.

The load carrying capacity, stiffness degradation, and cumulative energy dissipation curves presented in Fig. 13 and the values

reported in Tables 2–4 illustrate the potential of strengthened joints in presence of steel angles (EJANG1, EJANG2, and EJANG3) over the reference joints REJ1 and REJ2. The figure and the tables show that inserting angles to the corners of the specimen before wrapping it by ferrocement layers enhances the overall performance of the strengthened joints compared to specimens retrofitted by ferrocement layers only shown in Fig. 11.

**3.3.3.1. Strength envelopes.** Fig. 13 (a) shows the load carrying capacity versus the displacement for the studied specimens. It can be seen from the figure and Table 2 that the ultimate load values of EJANG1, EJANG2, and EJANG3 were higher than that of local reference exterior joint REJ1 by 11%, 16.10%, and 21.80% and they were higher than that of ACI detailed exterior joint REJ2 by 2.10%, 6.64%, and 11.87%, respectively. It can be argued that the specimen REJ2 was well confined initially by proper reinforcement details. Fig. 13(a) and Table 2 show that the ultimate load of EJANG1 was higher than that of REJ1 by 11% while the ultimate load of EJ1 was higher than that of REJ1 by 3.30% only (see Fig. 12(a) and Table 2). For the specimen, EJANG2, of two layers of ferrocement and steel angles, the ultimate load was higher than that of REJ1 by 16.10% while the ultimate load of EJ2 was higher than that of REJ1 by 7.6% only. This can be attributed to the better stiffening and confinement of the joint region as a result of adding steel angles in addition to the wrapping by ferrocement layers. This technique delayed and controlled the initiation and full development of cracks, and consequently minimized the joint deformation.

**3.3.3.2. Stiffness degradation and energy dissipation capacity.** Fig. 13(b), (c), Tables 3 and 4 show that the confinement provided by the ferrocement layers in the presence of steel angles was observed in the stiffness degradation and energy dissipation capacity curves for specimens EJANG1, EJANG2, EJANG3 compared to REJ1, and REJ2. By comparing Fig. 11(b) with Fig. 13(b), it can be seen that the specimens retrofitted by ferrocement layers without and with steel angles experienced a uniform pattern of stiffness degradation. However, Table 3 shows that the stiffness of the specimens retrofitted by ferrocement in the presence of steel angles (EJANG1, EJANG2 and EJANG3) was slightly higher than that for those retrofitted by ferrocement layers only (EJ1, EJ2 and EJ3) especially in the late stages of cyclic loading. Figs. 11 (c) and 13 (c) show that the strengthened joints without and with the presence of steel angles, EJ1, EJ2, EJ3 and EJANG1, EJANG2, EJANG3 almost followed a similar trend and they attained higher capacities of the dissipated energy compared to that of the reference specimen, REJ1. However, Table 4 shows that the joints retrofitted by ferrocement and steel angles attained higher capacity of the dissipated energy than that of the retrofitted joints without steel angles. Hence, the use of ferrocement layers in the presence of steel angles in retrofitting joints without shear reinforcement would enhance the behavior of these joints and would reduce the vulnerability of these joints to excessive damage when subjected to seismic loading.
