LIMITATIONS IN USING NON DESTRUCTIVE TESTS FOR ASSESSMENT OF CONCRETE SUBJECT TO ELEVATED TEMPERATURE

H. I. EL-SAYAD*

*Associate Professor, Faculty of Engineering at Shoubra, Banha University, Egypt.

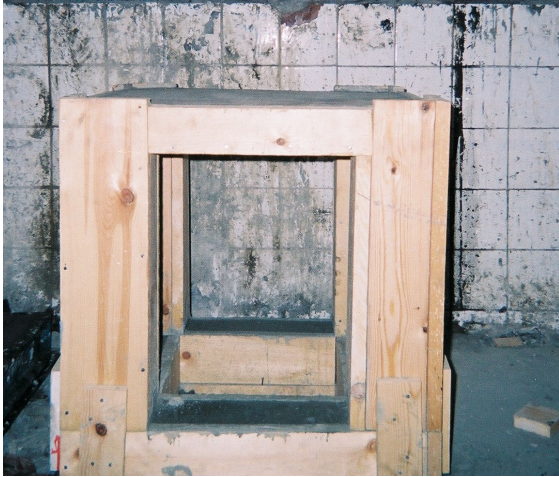
Figure 1 Model frame formwork

A specially designed and manufactured wooden formwork was used for casting the model frames. A frame, still in formwork, is shown in Figure 1. The frame consisted of a reinforced slab (width 600, length 600 and thickness 40 mm) resting on four reinforced concrete columns (cross section 100 x 100 and clear height 600 mm), which in turn were held at the bottom by four reinforced concrete ground beams (cross section 100 x 100 and clear span of 600 mm). Frame members were simply reinforced. The slab was reinforced by 5 longitudinal bars in the two directions with a diameter of 3 mm, providing a cover of 5 mm in all directions. The columns and ground beams were reinforced with 4 longitudinal bars with a diameter of 4 mm confined using a square stirrups/ties placed every 100 mm, providing a cover of 5 mm (Figure 2). More details are shown in Figures 3 and 4. Two model frame specimens and six 150 mm standard cubes were prepared from each mix. The specimens were cured under wet burlap for 1 day, and then in air for 40 days before being transported to the furnace for exposure to elevated temperature (Figure 5).

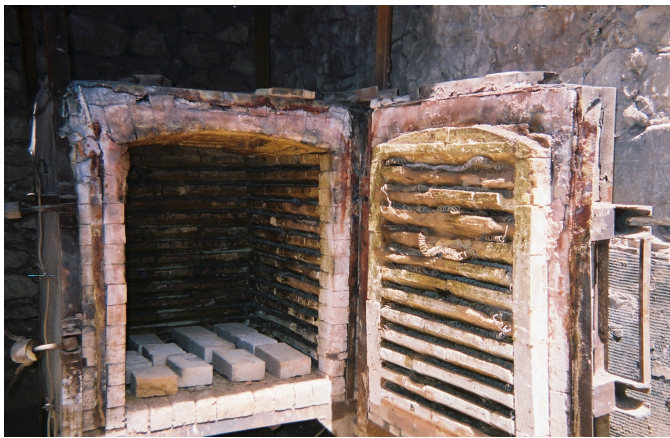
Figure 6 Interior Furnace details

The furnace used throughout the investigation was located in NATIONAL POTTERY CENTRE. The furnace had a plan area of 90X90 cm and a height of 120 cm, body made of steel, lined with a ceramic blanket, in which heaters were fitted closely from all sides (see Figure 6). The furnace heating rate was monitored and plotted in Figure 7. The target temperature of 800 °C was reached during a period of four hours. After that, the furnace automatically switched off. One hour later the doors were opened slightly to provide ventilation to the furnace. Room temperature inside the oven was reached 24 hours later. The heating rate of the furnace used in this investigation is much slower than the rate specified in BS EN 1363-1:1999 [34] for cellulose fire, and that encountered in hydrocarbon fire in which the temperature reaches 800 °C or 1100 °C in less than 15 minutes, respectively.

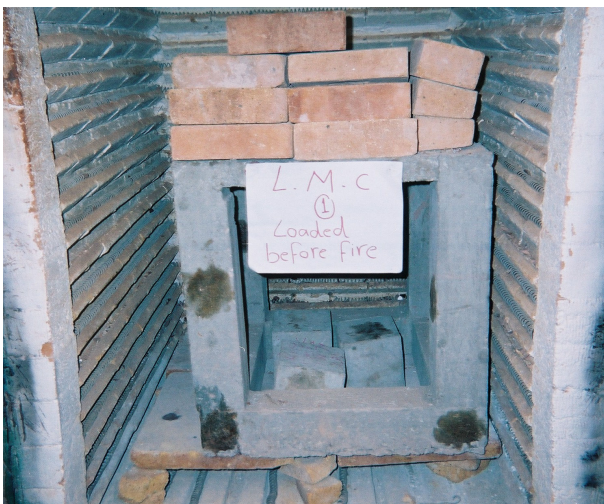
Figure 8 Loaded specimen with cubes prior to heating

One model frame sample, from each mix, was subjected to elevated temperature in a loaded state. Load was in the form of 33 uniformly distributed thermal bricks (total weight 100 kg) to simulate

a scaled down typical live load on the model frame (see Figure 8). The other frame was heated in an unloaded state (see Figure 9). Three cubes from each mix were also subject to temperature.

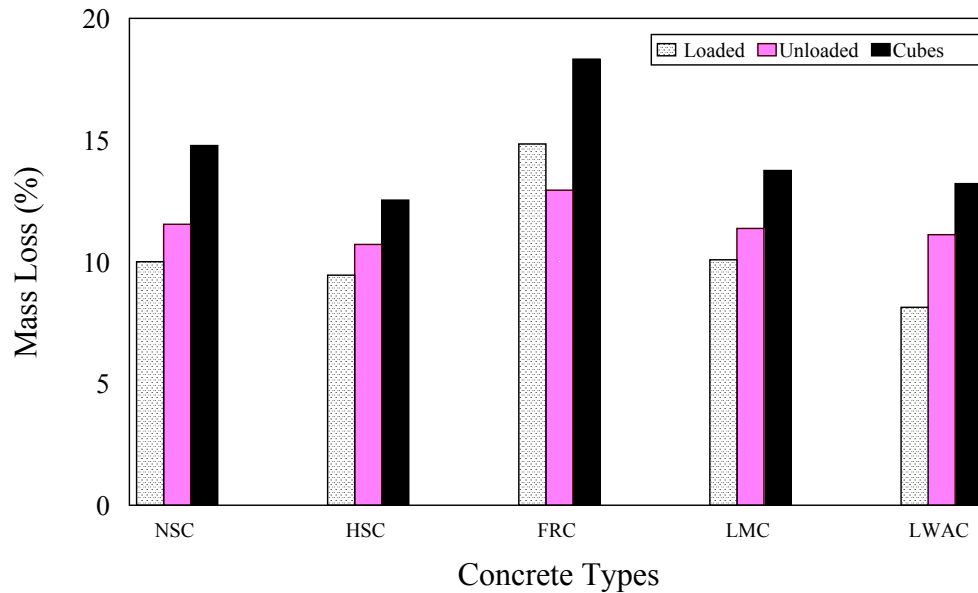
Figure 10 Effect of elevated temperature on mass loss of model frame samples and cubes

The mass loss results are shown in the Figure 10 for model frame specimens and cubes. The cubes had a higher mass loss than the model frame specimens probably due to higher surface / volume ratio of the cubes. In addition, it was observed that reinforcement may hold back the concrete cover, which act as a thermal shield preventing mass loss [1]. Mass loss results are limited in the cited literature. Hoff et. al. [41] heated HSC cylinders (D 150 mm X H 300 mm) made of limestone aggregated having w/c= 0.32 to 700 °C. The recorded mass loss was 6.68%. At higher temperatures a very rapid increase in mass loss was observed due to the dissociation of calcium carbonate in the limestone with the liberation of large amounts of CO₂. Therefore, the results of the current investigation with heating up to 800 °C (12.5% mass loss for HSC cubes) seems in line with the findings of Hoff et. al. [41].

The mass loss of FRC was higher than other types of concrete. This may be attributed to the ease of vapor dissipation in the porous network produced after melting of fibers at 160 °C [28]. In addition, the spalling exhibited by the samples of this type of concrete (see previous section) may have increased the mass loss results. Mass loss of NSC and LMC came in second place after FRC. For NSC, this may be attributed to the higher initial moisture content and permeability of NSC (as suggested by Kalifa et. al., [1]) compared with HSC, and to the spalling observed for NSC samples. The mass loss for LMC was in the same order of magnitude as the NSC. This is may be due to thermal degradation of the polymers in the Latex on heating above 200 °C [42]. The effect of this degradation on the microstructure of the heated LMC needs further study in order to fully understand the observed results for this concrete. The LWAC exhibited the minimum mass loss results. This is probably due to the higher porosity of these samples, which was visible by naked eye after samples preparation. This enabled efficient air drying of LWAC prior to exposure to elevated temperature, hence the moisture content was originally lower than the other samples.

It was found that the loaded specimens exhibited less mass loss than unloaded ones except for FRC specimens. Again the suggestion of Malhotra [4], as explained in the previous section, may apply in this case. In other words, moisture loss was more difficult in loaded samples. In addition, in slabs of loaded samples moisture was mainly lost from the bottom surface of the slabs due to the presence of load bricks. The high mass loss in loaded FRC samples cannot be explained especially if the spalling exhibited by their unloaded counterparts is taken into account.

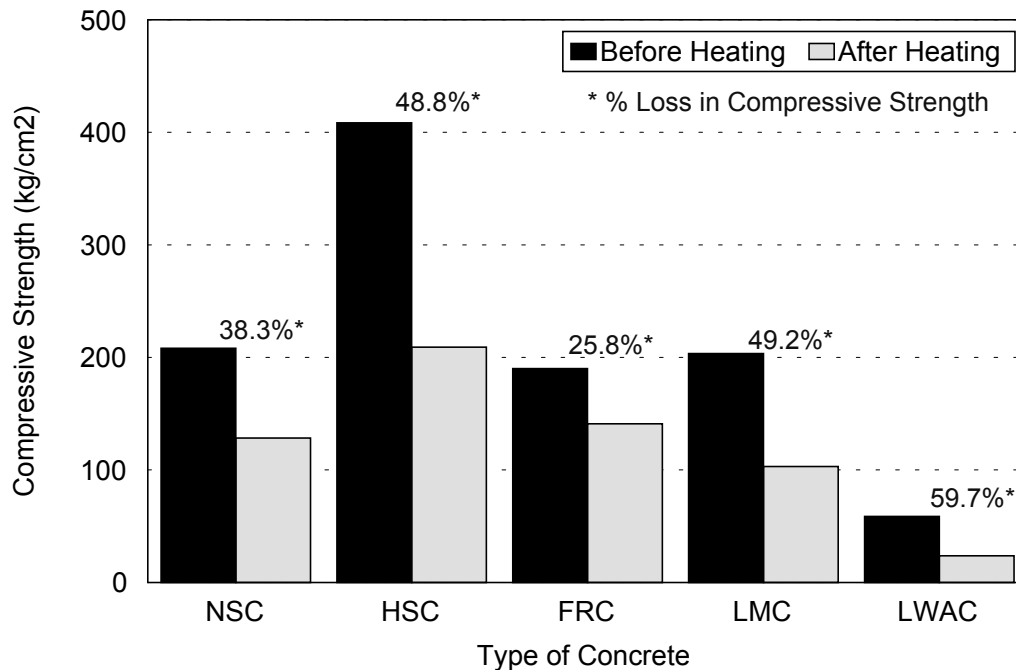
Figure 11 Compressive strength of cubes before and after heating

The compressive strength of the cubes made from the different types of concrete, before and after heating, is shown in Figure 11. Also shown is the percentage loss in compressive strength. It can be seen that the NSC, FRC and LMC had a comparable compressive strength to start with. However, heating to 800 °C, caused a different compressive strength loss for each type of concrete. A high loss was incurred by the LMC, which was even higher than that experienced by HSC. The effect of polymer melting in the latex, upon heating LMC to above 200 °C [42], on its mechanical properties at elevated temperature needs to be fully investigated. On the other hand, the melting of fibers in FRC has lead to quick vapor release and therefore a small strength loss occurred. HSC exhibited a much higher loss in strength than that of NSC, probably because of permeability differences. In addition, Malhotra [4] found that the leaner mixes undergo a smaller proportional reduction in strength when heated compared to richer ones. It would appear that the Leca, used in the preparation of LWAC, disintegrated at the high temperature and hence a very high strength loss was observed.

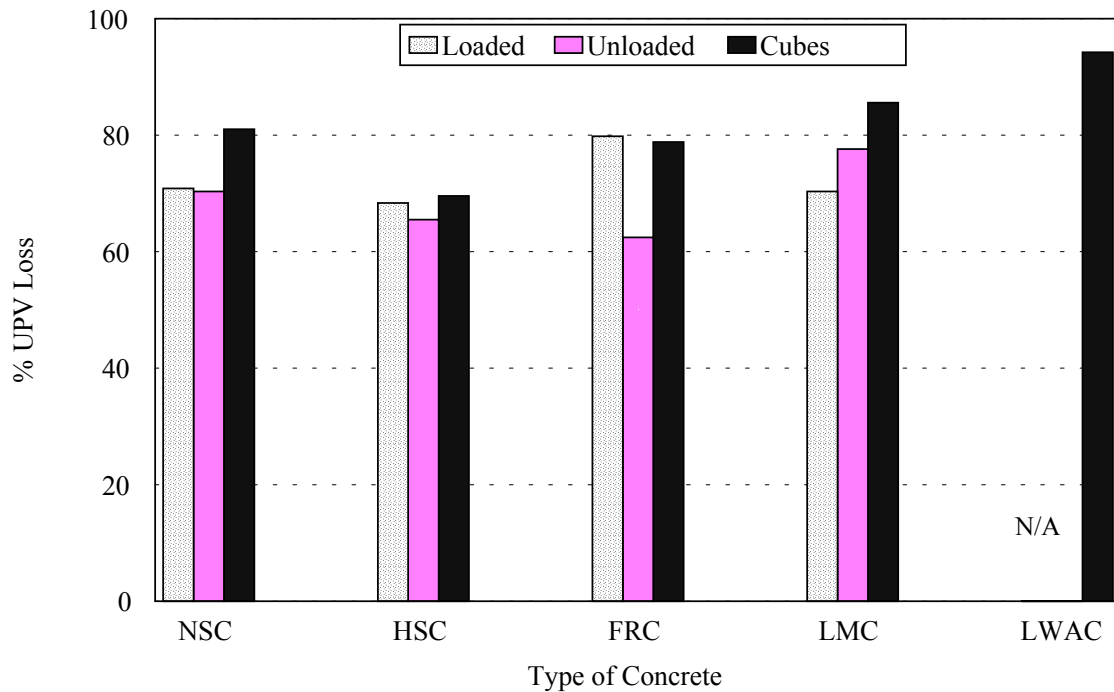
Figure 13 Percentage loss in ultrasonic pulse velocity for the model frames and cubes

The average UPV loss for each frame sample is compared to the loss of UPV experienced by the cubes made from the same types of concrete in Figure 13. The UPV loss for the cubes was greater than the average values for the model frame samples, and ranged between 69.5% for HSC and 94.23% for LWAC. It would appear that the % loss in UPV, for small laboratory samples, is dependant on the w/c and/or compressive strength of the original concrete. A similar observation was made by Malhotra et. al. [53] who found that concrete cylinders, made from natural gravel and having w/c ratio of either 0.23 or 0.71, heated to 450 °C for 72 hours, lost 44.2 and 58.4 % of their UPV values. Short et. al. [14] found that 100 mm cubes, having w/c = 0.62 to 0.66 and made of limestone aggregate lost 90% of their UPV values when heated to 700 °C for 1 hour.

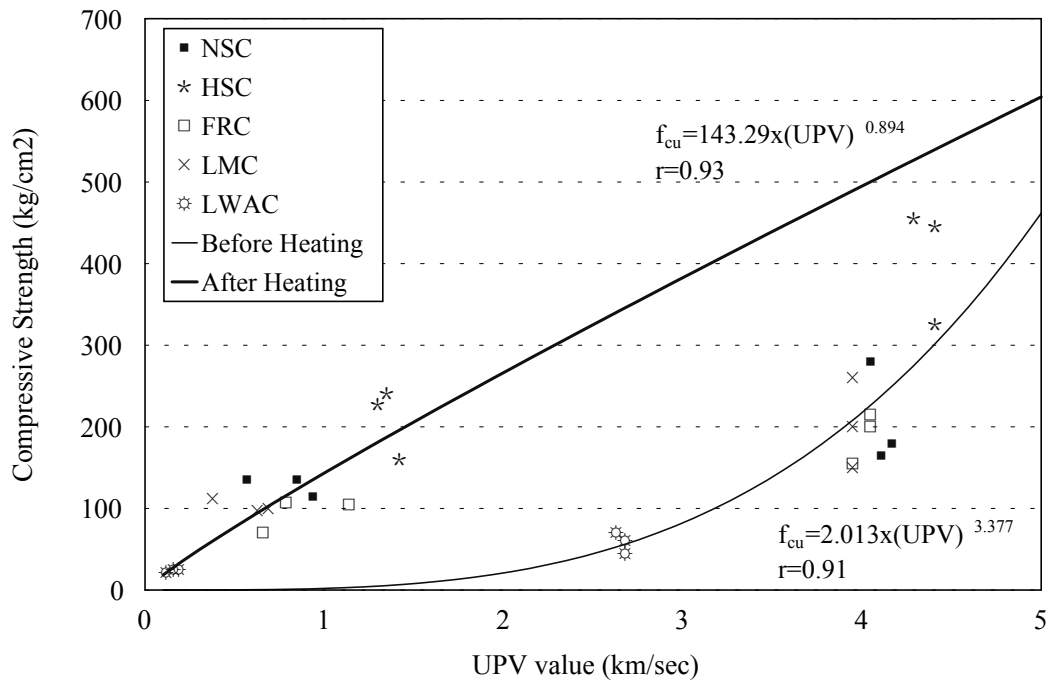
Figure 14 Effect of elevated temperature on the UPV- compressive strength relationship

UPV measurements were carried out on six cubes from each mix in this investigation. Before the measurements, three cubes were heated to 800 °C whereas the others were kept at room temperature. Subsequently, all cubes were tested for compressive strength. The UPV – compressive strength relationship for the heated and unheated cubes is shown in Figure 14. It should be stressed that these relations are only valid for the concrete tested. It can be seen that heating had a profound effect on the relationship. For example, based on these curves, a UPV reading of 3 km/sec means that the compressive strength of the concrete is 82 kg/cm², if the concrete was not subject to elevated temperature. The same reading would indicate that the compressive strength was 382 kg/cm² where the concrete has been affected by elevated temperature. This is in agreement with Lie et. al. [15] who pointed out that there is a significant decrease in measured pulse velocities for a given compressive strength for fire damaged concrete compared to the undamaged counterpart. Further investigation is needed in order to incorporate this effect into the recommended procedures for the assessment of structures after fire. In addition, more work is needed to establish the effect of thermal gradients in full scale structural members on both the core compressive strength and measured pulse velocity after a fire.

- 5- Pulse velocity-compressive strength relationship was profoundly affected by fire. For example, a UPV reading of 3 km/sec would indicate a compressive strength of either 382 or 82 kg/cm², depending on whether the concrete has been or has not been subject to elevated temperature, respectively. This needs to be taken into account in recommended procedures for assessing structures after fire.
- 6- More work is needed to establish the effect of thermal gradients in full scale structural members on both the core compressive strength and measured pulse velocity after fire.
