Problems of Embankments

Week 14

Subgrade Failure

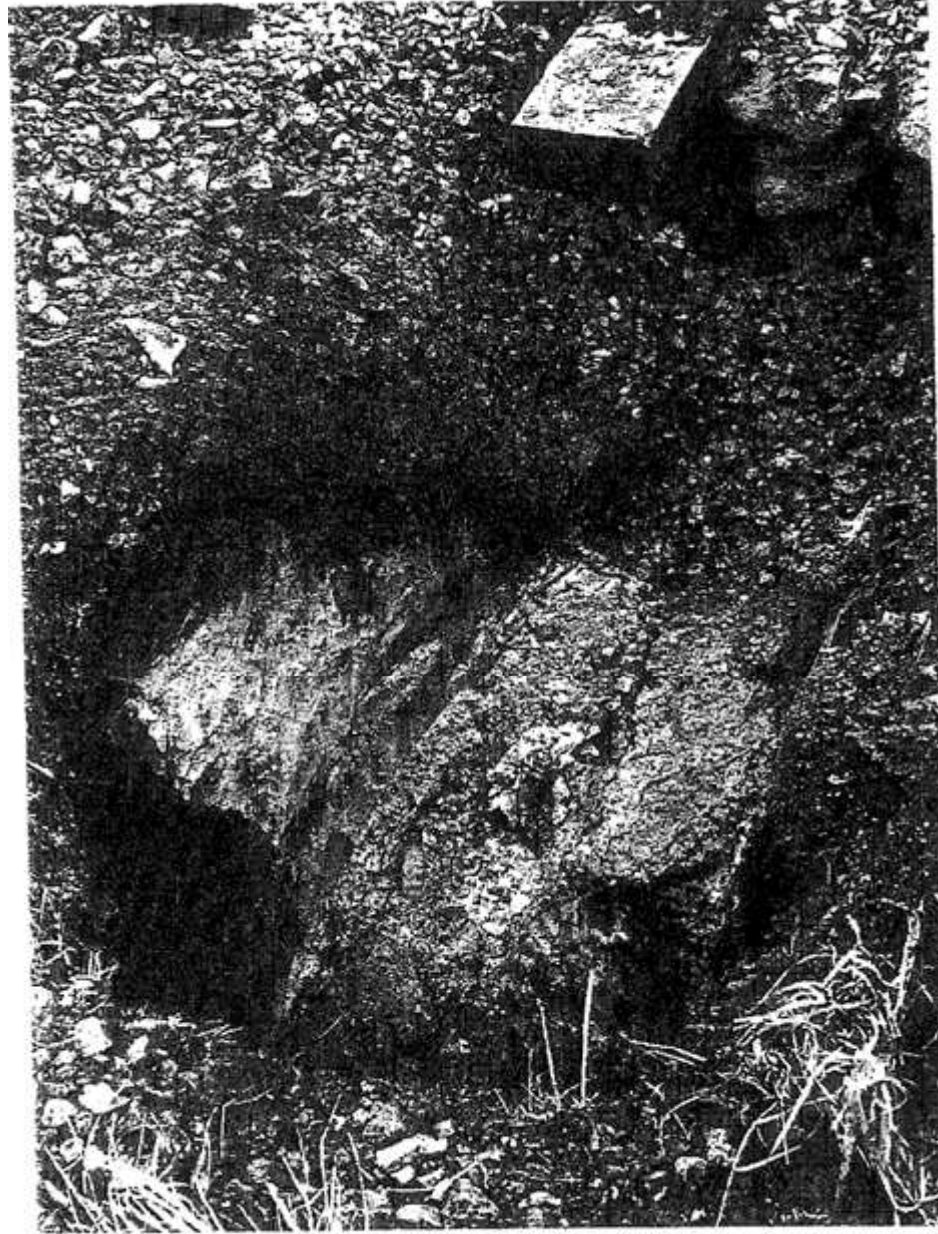
Fig. 5 Cess heave during formation

Figure 3 shows diagrammatically how overstressed clay is progressively squeezed sideways and upwards. Figure 4 is a photograph of a section through a cess heave during its formation. Figure 5 is a photograph of a section through a fully developed cess heave.

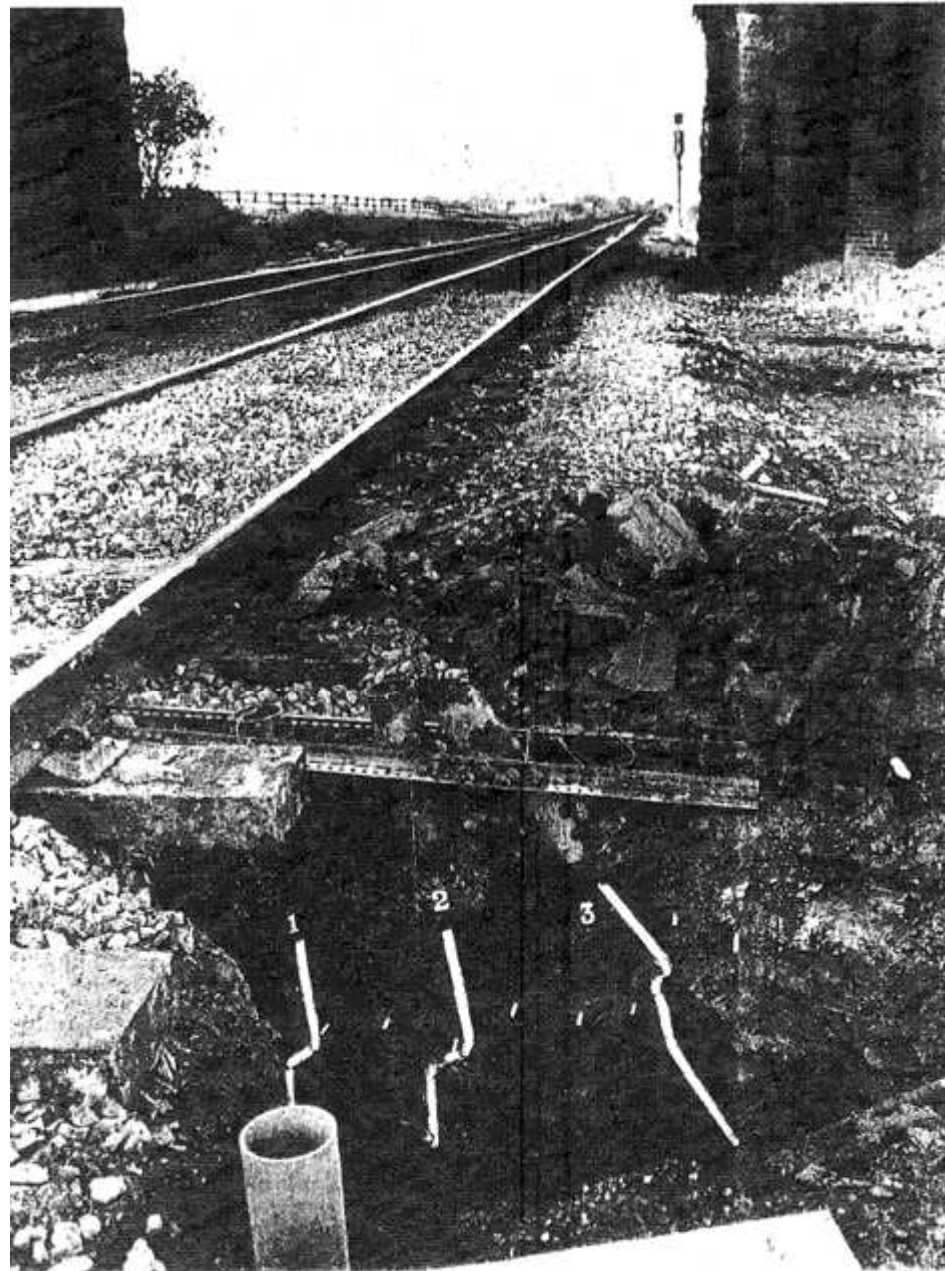
Figure 6 shows how three initially straight columns of segmented tubing have been distorted by the further development of a general subgrade failure. The columns of segmented tubing were initially installed by threading them onto a straight steel rod and then driving them into position

Fig. 6 Distorted columns indicating cess heave failure

Once in position, the rod was withdrawn, leaving the segmented tubing in position. After a period of several weeks, the trench was excavated alongside the tubes to expose them as shown in the figure.
