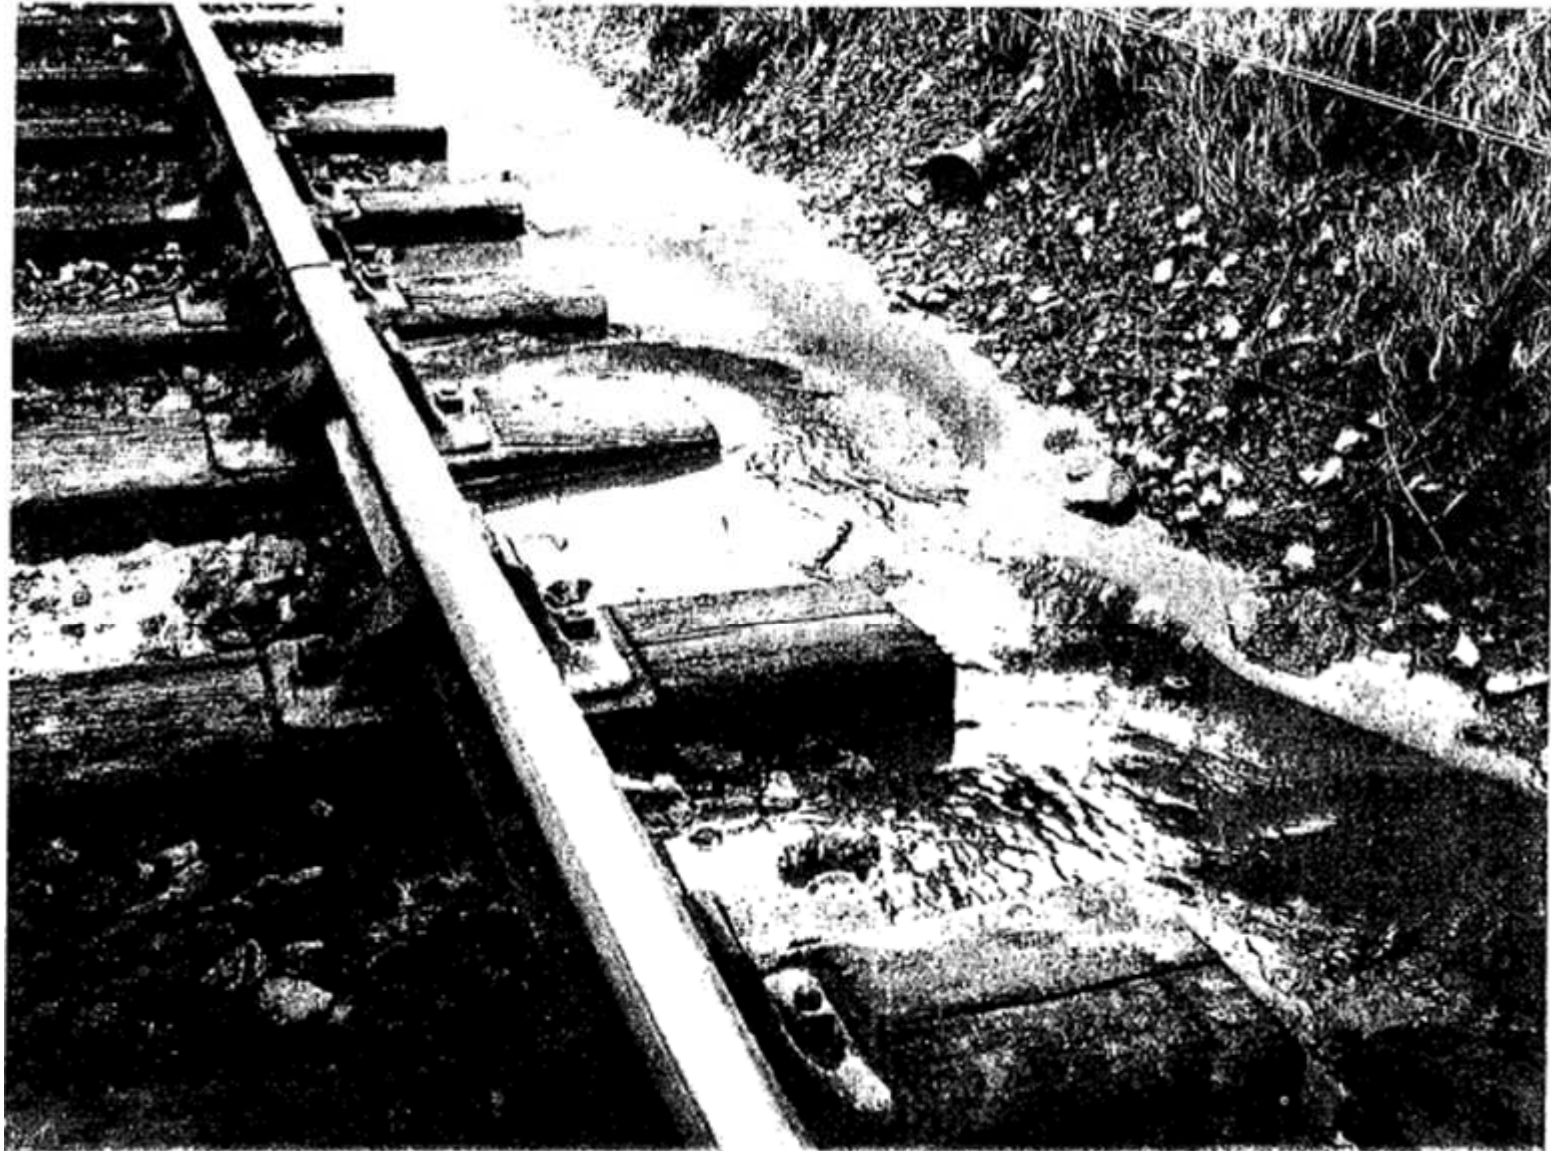
Fig. 9 Pumping of slurry from subgrade attrition

As shown in Fig. 9, when the slurry reaches the sleeper/ballast interface, cyclic movements of the sleeper within the ballast bed result in the slurry being ejected from beneath the sleeper on to the surface of the ballast to give the condition known as "Pumping". The slurry, in this case from subgrade attrition, ultimately finds its way into the trackside drainage system which can result in premature blocking.

The surface manifestations of a pumping failure are very similar to those associated with ballast/sleeper erosion and/or the presence of dirty ballast around the sleeper. Its cause and its cure are however quite different. An examination of the fine grained materials present in the slurry can usually indicate its source and hence the type of failure being encountered.
