# *Bacillus subtilis* as a Novel Biological Repair Technique for Alkali-Activated Slag Towards Sustainable Buildings

**Abstract:** Rebuilding using outdated methods and tearing down the buildings would have a negative impact on the environment without lowering carbon dioxide emissions or increasing sustainability. This study presents a novel approach to repair that considers environmental and sustainable factors. In contrast to conventional repair methods, the use of *Bacillus subtilis* as an external biological repair technique could offer a novel and sustainable solution, especially when used on alkali-activated slag (AAS) concrete. By breaking down urea into carbonate and ammonium, alkaliphile bacteria can precipitate calcium carbonate. In an environment rich in calcium, the bacteria's opposing cell wall ( $\text{CO}_3^{2-}$ ) draws in positive calcium anions, which result in the formation of calcite crystals. The pores and crevices in the concrete are filled with these crystals. Incorporating bacteria into the fresh mixing of AAS ingredients is contrasted with using *Bacillus subtilis* culture in the water curing medium for pure AAS specimens. The effectiveness of both approac

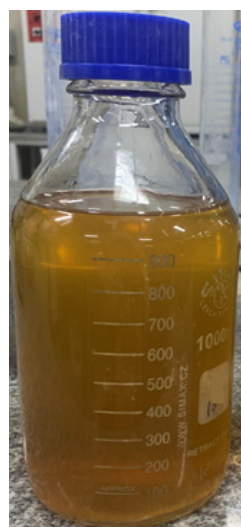
**Figure 1.** *Bacillus subtilis* culture.

Figure 1 represents the *Bacillus subtilis* culture prepared with the target cell concentration of  $10^5$  cells/mL. The alkaliphile *Bacillus subtilis* is a resilient spore-forming bacterium with the ability to survive as spores. These spores remain dormant until cracks form and moisture activates them, triggering calcite precipitation to heal cracks [27]. This type of bacteria could survive within alkaline environments such as concrete, which has a high pH (ranging from 12 to 13). The selection of *Bacillus subtilis* was attributed to their greater resilience to alkaline conditions than other bacteria [27]. The microbial sample of *Bacillus subtilis* was performed at the Faculty of Science of Al-Azhar University, Cairo, Egypt, similar to those prepared by Shaaban et al. [17]. The *Bacillus subtilis* sample preparation is summarized as follows: the bacteria were cultured in a formulation composed of 1% tryptone, 0.5% yeast extract, 1% NaCl, and 1.5% agar. The second step was sterilizing all glassware and instruments for 20 min, which was an important step to avoid contamination by other species. The inoculation process included preserving bacteria for 24 h at 37 °C.

microbes' growth rate. The OD and CFU/mL measurements were repeatedly recorded up to 0.1 OD to spot the required concentration level. Table 2 indicates the main characteristics of the microbial culture. It should be mentioned that the supernatant was then centrifuged at 10,000 rpm at a pH of around 10.5 and the bacteria produced complied nearly with those provided by *B. subtilis* strain 168 (ATCC, Manassas, VA, USA). The bacteria and culture medium were prepared and tested for pH, etc., as mentioned earlier outside the civil laboratory of the German University in Cairo, as shown in Figure 1.
